FACILITY CONDITION ASSESSMENT

WILDWOOD TOWNHOMES

October 2020

SGM Project #2020-295

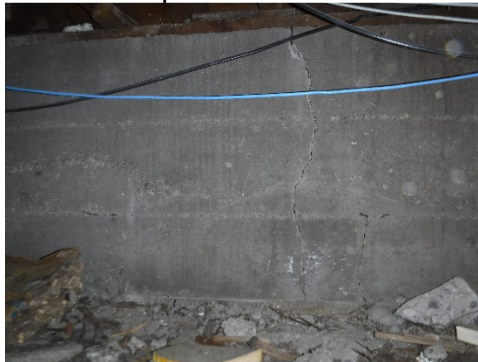
Everywhere else (buildings 2, 3, and 4) the majority of the foundation was observable from the crawlspace and exhibited minor cracking, which is to be expected for foundations of this age. In general, they are in good condition. In building 4 the actual concrete has been insulated with spray foam and was therefore unable to be observed directly, but there are no indications of issue with it on the outside of the building or on the spray foam. Ideally, as discussed in the Mechanical and Plumbing Systems Assessment section, all of the concrete foundation walls should be insulated similarly to those in building 4 to prevent the freezing of water and sewer lines in the crawlspaces.

Foundation wall - Cracked but in reasonably good condition

It is recommended that the items discussed in this section continue to be monitored every five years to ensure that no new problems arise.

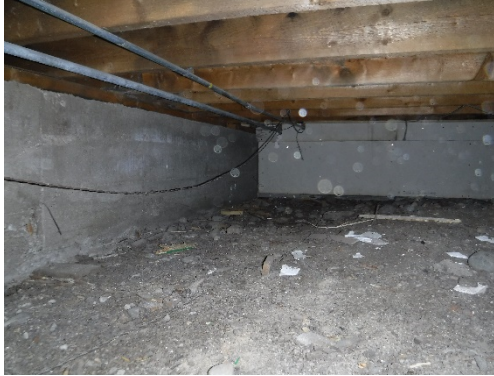
Typical floor framing

Both the floor joists and the subfloor are in good condition despite their age. There were very few signs of rotting or water damage. There were also very few signs of distress in them from loading on the floors above. Many of the floor systems also have mid-span knee walls that vary from newer post and beam systems to old concrete walls. These walls are in fair to good condition and still have useful life remaining. There were several areas that appeared to have previously been wet that are currently dry. It is likely the source of that water has been identified and fixed so there is no current issue. However, when crawlspaces are monitored in the future any spot that is currently wet should be immediately noted and the source of the water identified and fixed.

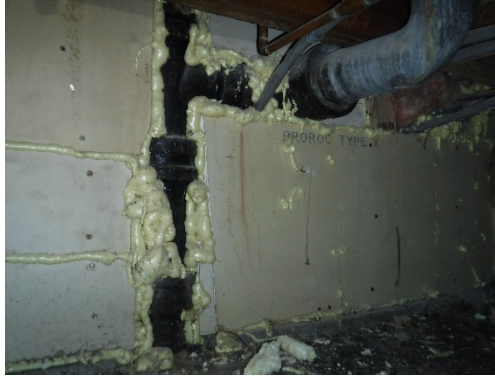
One area of the framing that needs to be addressed is the fire walls between units in buildings 2, 3, and 4. Fire walls between units are a code requirement and many of the walls in the crawlspaces have been knocked down over time, presumably to create easier access for repairs between units. In other areas there are pipes penetrating or running inside the fire walls. The attics spaces were unaccessible at the time of inspection, but fire walls should also extend into the attic space for the full height between the ceiling and the roof.

Sewer pipe running through fire wall.

3. The crawlspace of each of the buildings should be renovated to create a conditioned space. During this renovation water and sewer lines should be removed and replaced with new lines that are installed per current codes. The existing fire walls should be demolished and replaced with new fire walls that meet current codes. The existing walls should be replaced because the existing sewer lines run through them and will need to be accessed and the damage done to many of them will make it difficult to fix with an acceptable manner. Lastly, each crawlspace should have a robust and continuous vapor barrier installed.

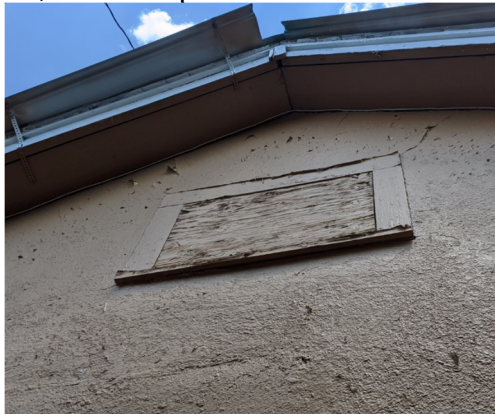
Louvers and vents: Attic vents appear to be present on Buildings one, two, three and four. Mechanical intake or exhaust louvers did not appear to be present, as noted in the mechanical section and this supports our opinion that there is no mechanical ventilation. Building two attic vents are intentionally blocked. The reasons for this are unknown. Assuming a typical construction in which the thermal envelope is above the ceiling (as opposed to the roof level) and the attic cavity is outside the thermal envelope, an unvented attic could lead to moisture problems and possibly ice damming. The next time a unit is being remodeled, or when available, the attic spaces should be assessed.

Attic vent blocked off on Building 2.

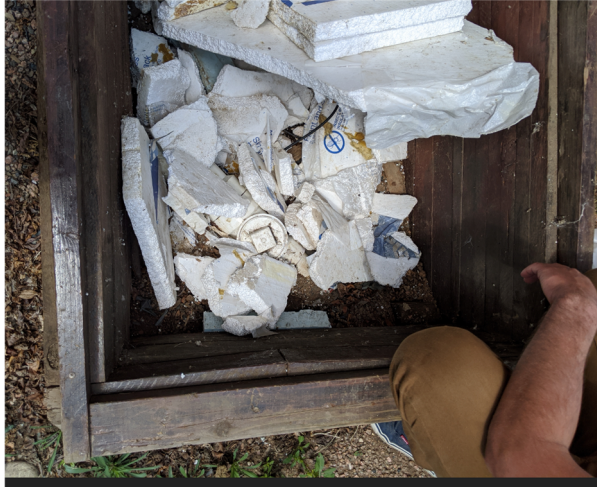
Another area of concern is the unsanitary state of some of the crawlspaces implies that maintenance is probably not occurring or would be difficult/dangerous to maintenance staff when it does occur. Accesses were typically in very poor condition and filled with trash.

Trash blocking crawlspace access.

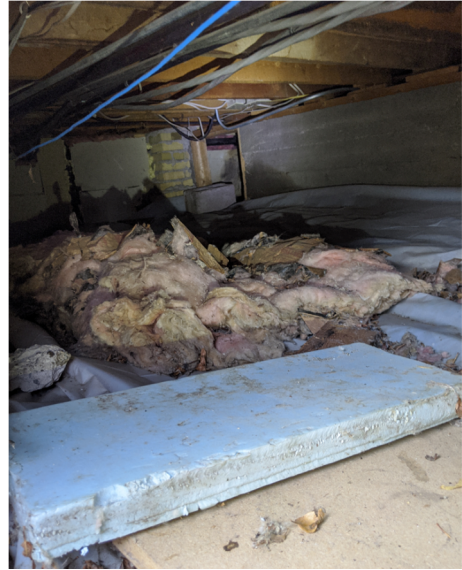
The crawlspaces have several items of concern. Insulation was not present below the floor but appears to have been added to the foundation perimeter in some areas, and some of the access covers were vented. Collectively, this implies that the crawlspace is indirectly heated from the space above. A vapor barrier is present in some of the crawlspaces, but in many cases is "hodge podged" together and is therefore ineffective due to its poor installation. The absence of perimeter insulation combined with indirect heat source results in freezing pipes, which is the current condition of many of the units. A proper crawlspace would have continuous insulation along the perimeter of the foundation, a robust and continuous vapor barrier, and a small amount of code required ventilation to prevent moisture build up. Other options exist but the presence of distribution piping and lack of floor insulation imply the above is the appropriate corrective approach and consistent with currently adopted codes.

Damaged/uneven insulation.

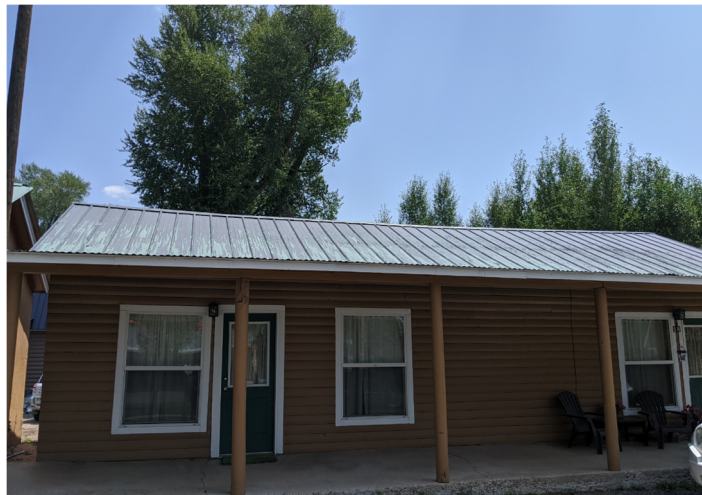
Roofs are standing metal seam for all buildings, and all (except one building outside the scope of this report) lacked a gutter system. The roof of building one was in poor condition with significant sag and peeling paint. Because the crawlspace of building one is inaccessible, we can't currently say whether that sag is due to foundation issues or an issue in the attic. As noted below, the lack of gutters or a longer roof eave is likely causing damage to other areas of the building envelope and accumulation of moisture in unwanted areas.

There also appears to be an old shingle roof beneath the current metal roofing. The metal roofing was installed directly on top of the shingles. It is possible that the old shingle roof contains asbestos due to the age of the buildings. This should be tested if/when the building roof is replaced.

Sagging roof and peeling paint on Building 1.

4. The old shingle roof under the newer metal roof should be tested for asbestos. If the shingles contain asbestos the cost and difficulty of the roof replacement or rehabilitation increases greatly. Once this information is known an accurate cost and plan for the roofs can be made.
5. The roofing and siding should be replaced. While they are in serviceable condition currently the issues with water penetrating the siding and the siding cracking will become worse with time. Once this phase of the rehabilitation is reached the wall framing will have been inspected and it will be known whether the old roof shingles contain asbestos and a comprehensive plan for the roof and siding replacement can be made.

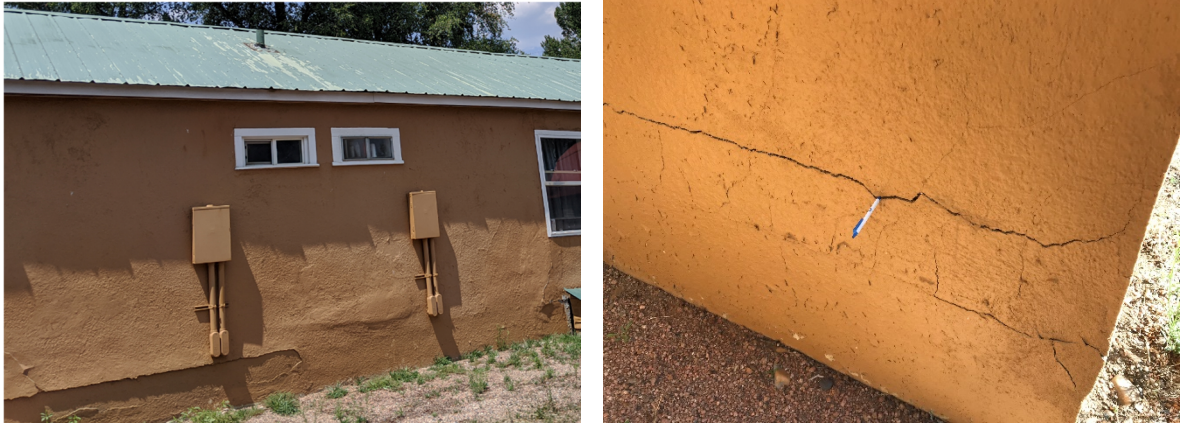
Stucco siding on the back of buildings one and two extend down to, and in some cases below, grade level. Cracking has occurred at the interface between the concrete foundation and building framing. This is likely exacerbated by the roof draining directly down the side of the building and moisture migrating up from the surface of the ground that it is in contact with. Additional cracking was observed below the tenant window sill, likely due to insufficient draining and sealing down the side of the building. Overall the stucco is in poor condition.

Cracked stucco at crawlspace and window sill or foundation

2. A section of the existing stucco should be removed to allow the interior of the walls to be inspected. This will provide a better insight into any damage that is occurring inside the walls where it appears water is infiltrating the siding. The location for this investigation should be next to a window so that the window the surrounding framing can also be inspected. During this investigation Unit 18 should also be investigated further. This could be done by doing the test siding removal on this unit.

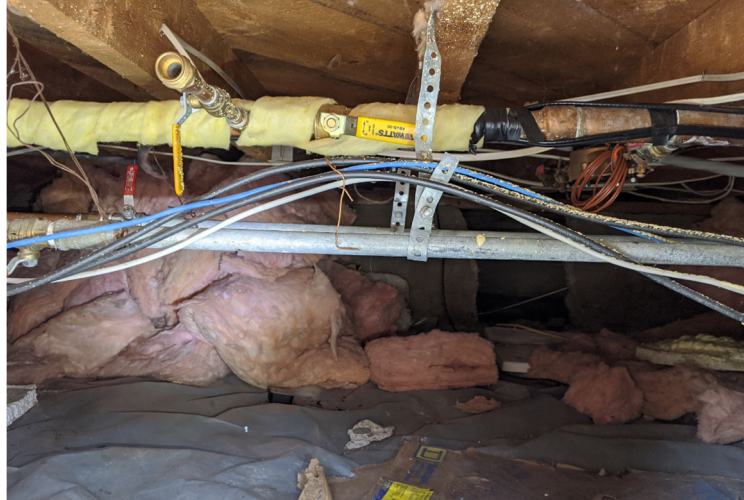
- Distribution piping below crawlspaces is not labeled, making troubleshooting and repair difficult.
- Crawlspaces are not conditioned, resulting in potential pipe freezing issues.

- It appears that domestic hot water piping insulation is poorly installed.
- Dwelling unit ventilation appears to be largely absent. While natural ventilation methods may be present via operable windows, it is unlikely adequate.

General disarray of utilities in crawlspace. Note the incomplete piping insulation, lack of labeling, and exposed piping end at branch secured only by valve closure.

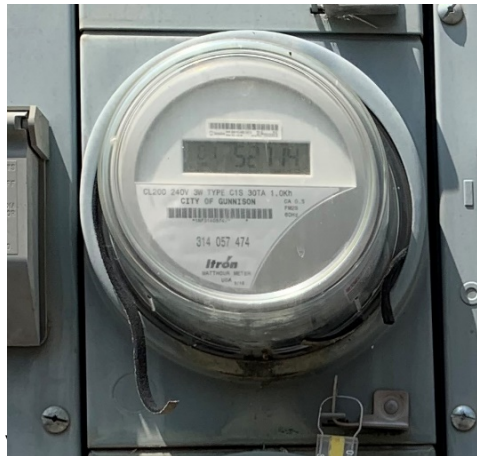
The manufacture dates of the residential branch panels at Wildwood are in the 2002-2003 range based on date codes written in the panel doors. The circuit breakers in the meter centers did not have any visible date labels, but they appear to be older. The outdoor locations of all these breakers shortens the expected lifespan (due to dust and heat). Therefore, the meter center breakers are probably past replacement age and the residential branch breakers are close to replacement age. While age alone does not constitute an immediate safety hazard, aged circuit breakers may fail to operate when needed and potentially result in fires or injury. We recommend replacing both sets of breakers as soon as practical, prioritizing the meter center breakers. The meter sockets themselves also show signs of age-related deterioration.

Aging Meter with Deteriorating gasket

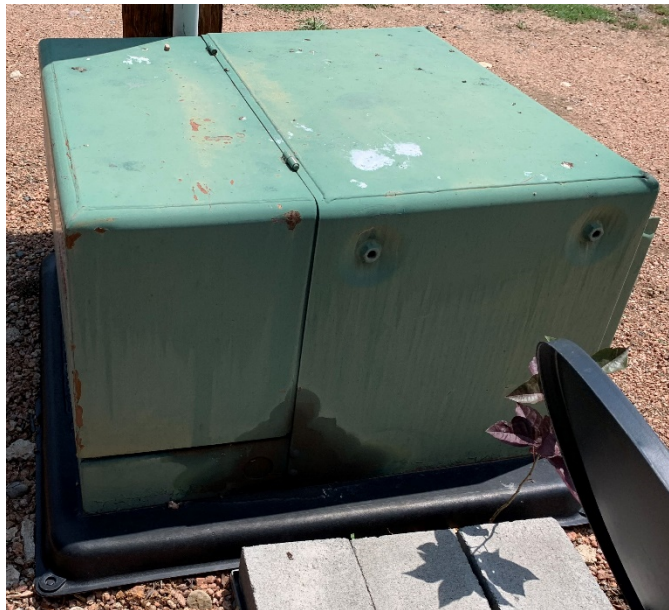
The two utility transformers show evidence of settling, rust, and water ingress. The transformer on the east side is in considerably worse condition than the west. Since this equipment is owned and maintained by the electric utility, we recommend scheduling an inspection by utility personnel and requesting that the transformers be replaced and/or reset on new pads (the utility has authority on this decision).

East Transformer Water Ingress

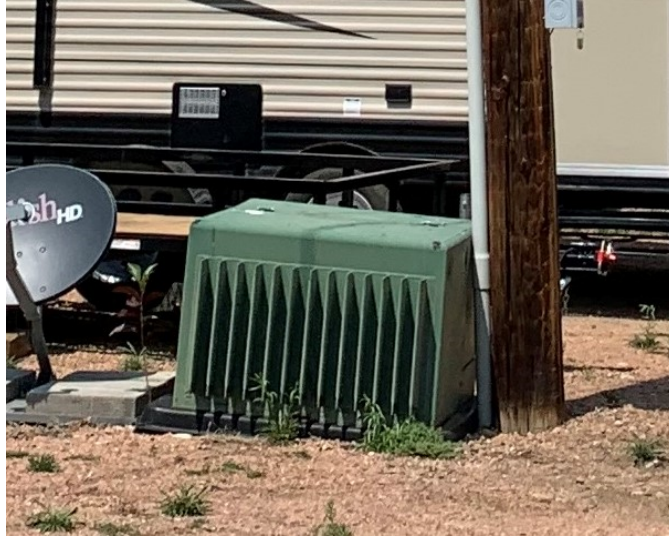
East Transformer Settling

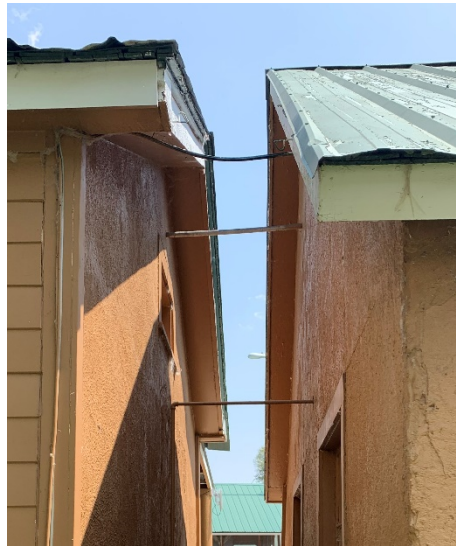
We observed unmarked conduit spanning gaps between buildings. We could not determine what it was, but it is likely to be a code violation. Separate buildings must only be supplied by a single incoming feeder that lands on a main breaker or fused switch that serves as the disconnect for that building. Other circuits cannot enter the building elsewhere.

Conduit and Cable Between Buildings

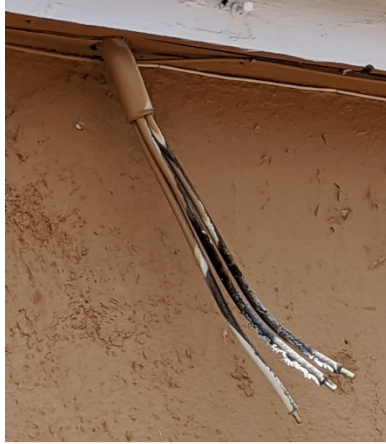
Throughout the site, the electrical system has been modified over the years. In several places, old wiring has been cut and left exposed rather than being removed. It is unknown if these wires are still connected to a power source, but they could be a safety hazard if so.

Example of Cut Feeders

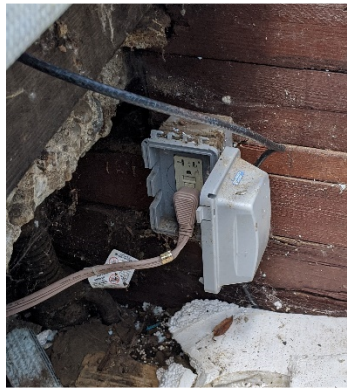
Exterior receptacles can have two types of weatherproof cover - the “while in use type” maintains a weatherproof rating while a cord is plugged in by closing over the cord. The less expensive standard type is only weatherproof when the receptacle is not in use. On the Wildwood site, most exterior receptacles are not weatherproof while in use but some had cords plugged in and left unattended, creating a shock hazard in the presence of any water. We recommend the replacement of all standard exterior receptacles with “while in use” types, and/or enforcing a policy of only using exterior receptacles for temporary, supervised uses.

*Example of Improper Use of Exterior Receptacle
(Note that the cord is also not rated for outdoor use)*

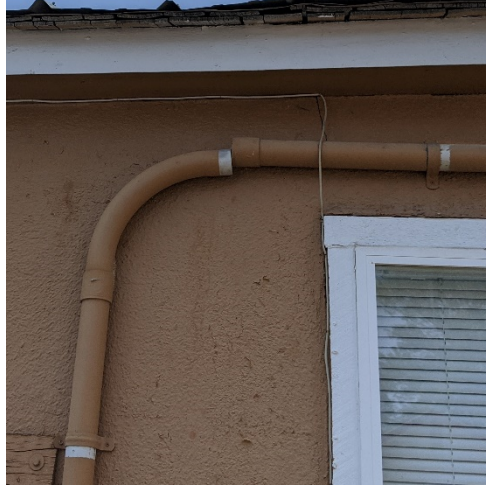
The conduit feeding Unit #19 from Service A shows evidence of significant movement. There is one section completely separated, and unpainted bands have moved from behind supports where they originally were. This feeder should be replaced, and the reasons for the movement addressed.

Conduit Separation

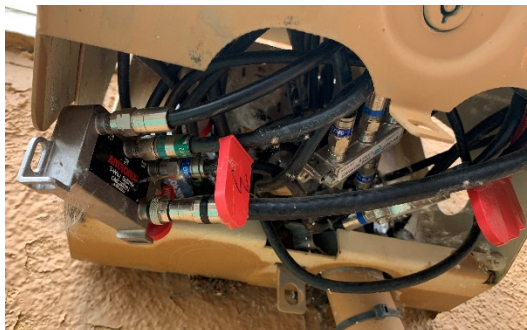
Throughout the site, exterior communications cabling was installed poorly. Cables are not consistently supported per code, and some boxes are overfilled and unable to be closed.

Overfilled Box

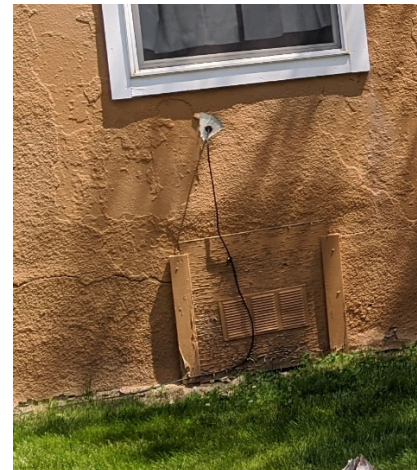
Improper Cable Installation
