Plaza Condominiums
11 Snowmass Road
Mt. Crested Butte, CO 81225

Level 1 Reserve Analysis

Report Period – 01/01/11 – 12/31/11

Date of Property Observation - July 15, 2010
Project Manager - Steve Kelsen
Main Contact Person - Mr. Eli Haine, Community Manager

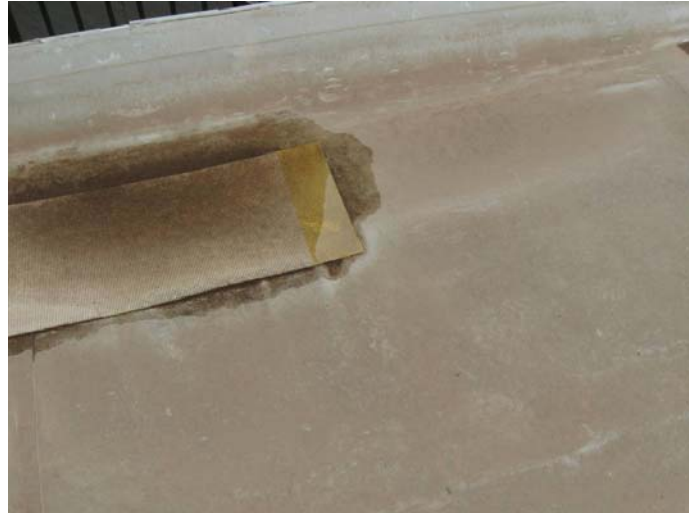
Comp #: 104 Duralast PVC Membrane Flat Roof - Replace

The building roofing was last replaced in 2003 and the Ski Locker roof in 2006. According to the installing company United Roofing, the roof holds a 15 year material and labor warranty from the date of installation. There is a possibility that the roof could last beyond the warranty but it is recommended by both us and the roofing company to place the Useful Life at the end of the 15 year warranty period to be sure funding is in place for replacement. Repairs to the roof from required snow shoveling should be made annually as an operating expense. There was a tremendous amount of ponding observed and evidence of numerous patches during the inspection. Remaining life is based on age since the last replacement.

Best Cost: **\$149,900**
\$5.50/GSF; Estimate to replace

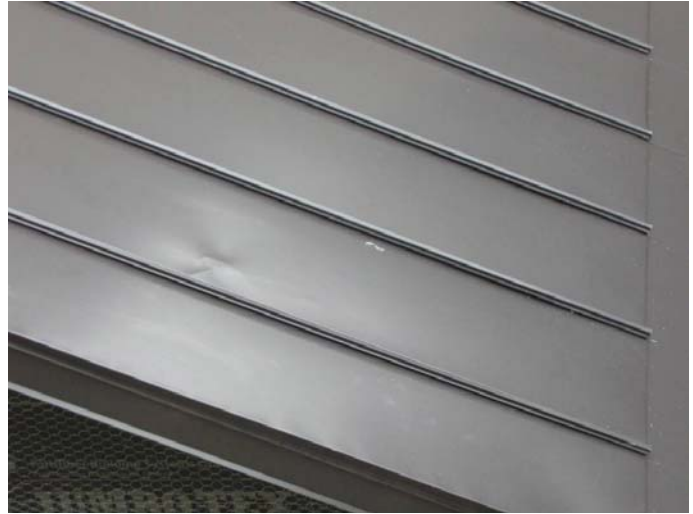
Comp #: 108 Standing Seam Metal Roof - Replace

All roofs were installed in 2010 as part of the third level exterior refurbishing project. In this climate, the average life expectancy for this roof ranges between 25 - 30 years, depending on the quality of the material installed. This is included as a replacement item (even though the roof can last much longer) per the suggestion of roofing contractor's we have done research with. This component is now part of the 3rd level remodel component #2020 and remains as reference only at this time.

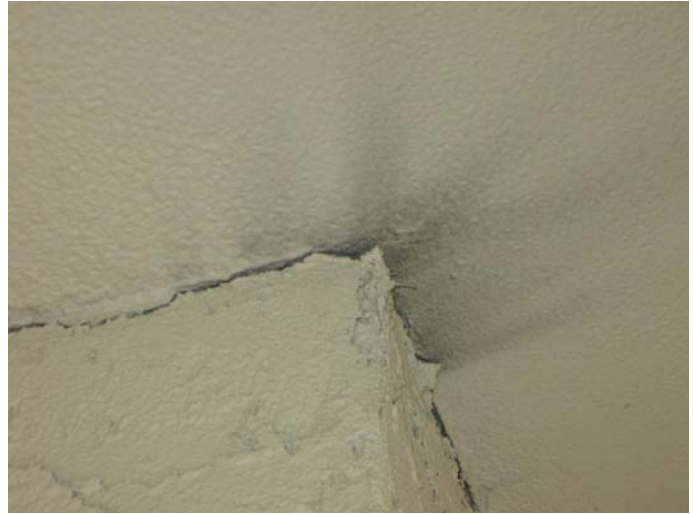
Comp #: 204 Building Ext. Surfaces (Courtyard) - Repaint

The courtyard exterior painted surfaces are generally in poor condition with significant rust marks, cracked/peeling stucco and paint. It was reported that the Association plans to repaint the entire building exterior during the fiscal year 2011/2012. In addition, we have cycled the exterior courtyard surface to be painted every 5 years and the building perimeter every 10 years at the request of the Association. The cost of painting the Courtyard and Building Perimeter every 10 years is calculated by combining Component #'s 204 & 205. The remaining life is based on observations and the plan established by the Association.

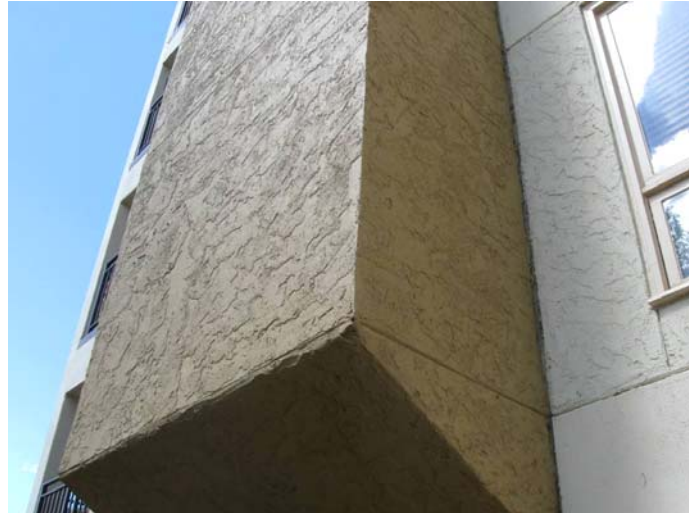
Comp #: 205 Building Ext. Surfaces (Perimeter) - Repaint

The perimeter exterior painted surfaces are generally in fair condition with some cracked, peeling stucco and paint. It was reported that the Association plans to repaint the building exterior during the fiscal year 2011/2012. Remaining life based on average condition. The Association should plan on painting the perimeter exterior surfaces of this building every 9 - 10 years. The Remaining life is based on observations and the plan established by the Association.

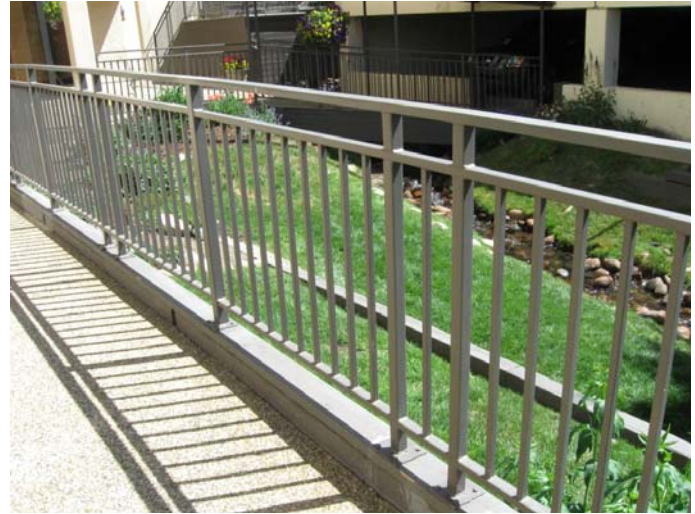
Comp #: 207 Metal Railing - Repaint

Painted wrought iron surfaces are new in 2009 and in good condition with no rusting or broken welds noted. It looks like the initial coat of paint is a baked on enamel finish. This initial coat will last between 8 - 10 years depending on the exposure to elements and quality of the finish. Thereafter, this component should be completely repainted every 10 years and with annual touch up to maintain appearance and protect metal surfaces. Annual touch up costs should be handled through the operating budget. Remaining life is based on coordinating handrail painting with the Building Perimeter painting every 10 years (see component #205).

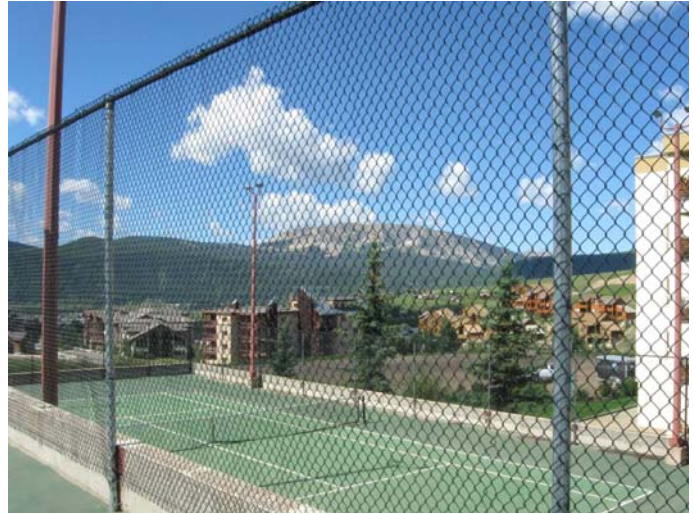
Comp #: 210 Chain Link Fencing - Repaint

The chain link fence surrounding the tennis courts is generally in fair condition but should be painted in the next 2 - 3 years. Expect to repaint this fencing approximately every 5 - 6 years to maintain appearance. Coordinate with other exterior painting for best cost estimate. Remaining life is based on observed conditions.

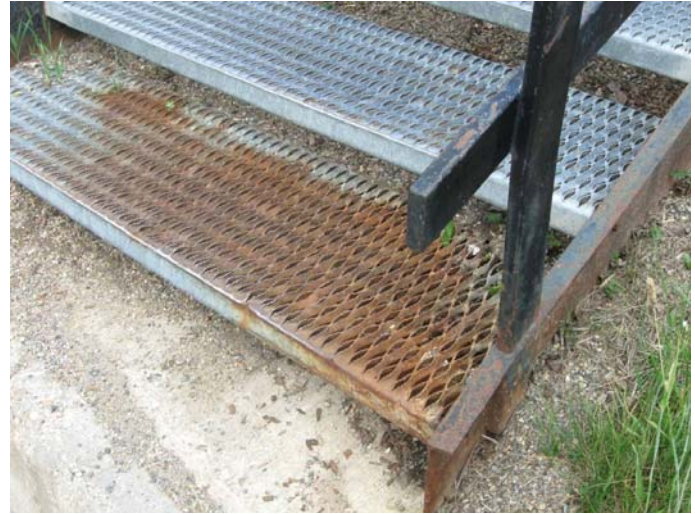
Comp #: 212 Steel Stairs - Repaint

Painted metal surfaces are in fair to poor condition. Expect to paint the railings for these surfaces approximately every 3 - 4 years to maintain appearance and protect metal surfaces. Funding has been removed at the request of the Association since this will be handled as an annual maintenance expense out of operating funds.

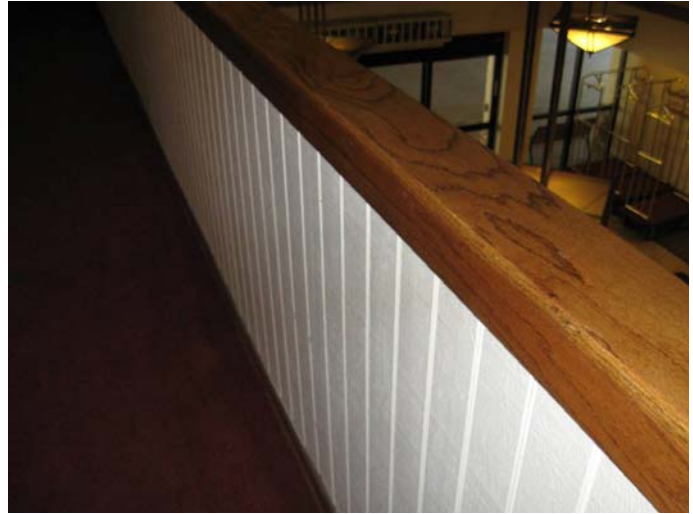
Comp #: 216 Interior Surfaces - Repaint

Surfaces are generally in good to fair condition with no major signs of wear or marks. Depending on the level of use and abuse, expect to repaint these surfaces every 7 - 10 years. The remaining life is based on the observed conditions and age of the building. In between painting cycles, we recommend touching up areas on an as needed basis with general operating funds.

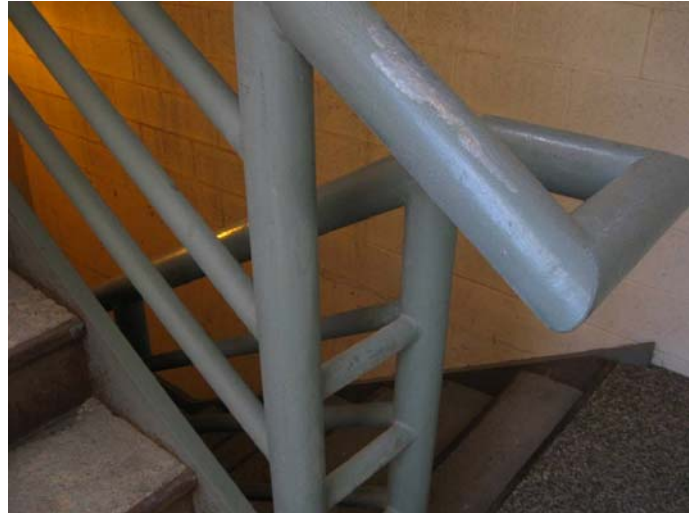
Comp #: 218 Interior Stairwells - Repaint

It was reported that the stairwells were last painted in 2002 and a beginning to show signs of deterioration with marked walls and chipped paint. Based on the "Six Year Capital Plan" established by the Association, plan to repaint these stairwells every six (6) years beginning this coming 2010/2011 fiscal year. Remaining life is based on the observed conditions and the plan.

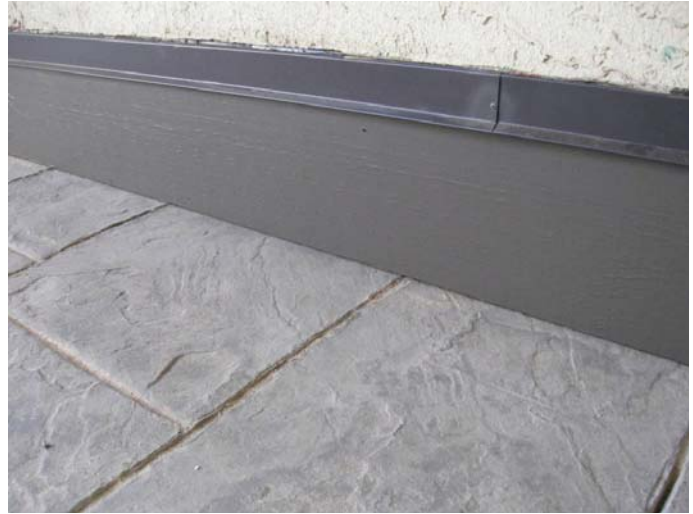
Comp #: 303 Pressure Treated Wood Base - Repair

The base with flashing is constructed of 2 x 10 Pressure Treated Douglas Fir material and was part of the 3rd floor refurbishment project. It is new and in excellent condition. Reserve to replace every 18 - 20 years due to exposure to the elements. This component is also part of the 3rd level remodel component #2020. The 3rd floor remodel cost has been reduced by the amount in this component.

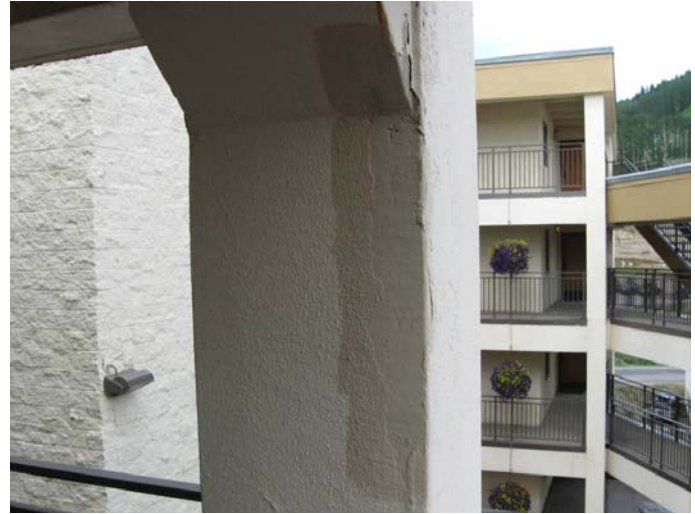
Comp #: 307 Stucco - Repair

The majority of the stucco surfaces are in fair to poor condition with the exception of the chimney chases which were recently replaced with all stucco and is the newest stucco surface on the building. While stucco surfaces have a long life expectancy, it is recommended by industry professionals that it is inspected and any voids are repaired every 4 - 5 years to prevent water intrusion into substrate. It is also recommended that a new coating is applied every 8 - 10 years to maintain an appropriate appearance (see component #204). Over a period of time, minor cracks and voids will develop that will require repairing. Coordinate these repairs with a painting cycle every 10 years.

Allowance for repairs

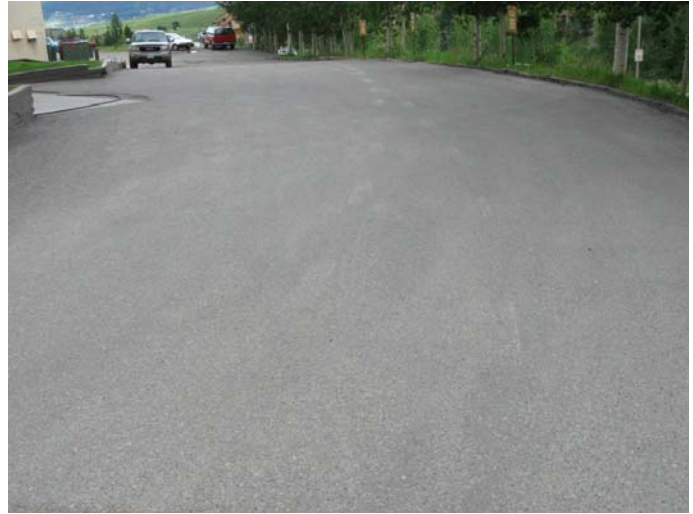
Comp #: 401 Asphalt (2) - Overlay

The north parking lot @ entrance to the lobby and upper parking garage are in fair condition. It was reported that based on the "Six Year Capital Plan" established by the Association, the asphalt in this area will be replaced in the 2012/2013 fiscal year. The average life expectancy for asphalt surfaces in this environment ranges between 13 - 17 years for surfaces that are maintained on a regular schedule. Maintenance includes crack fill and repairing small potholes annually as an operating expense. In addition, asphalt in this environment should be seal coated every 2 -3 years. Remaining life is based on the observed conditions and the plan.

\$4.00/GSF; Higher estimate for local repairs

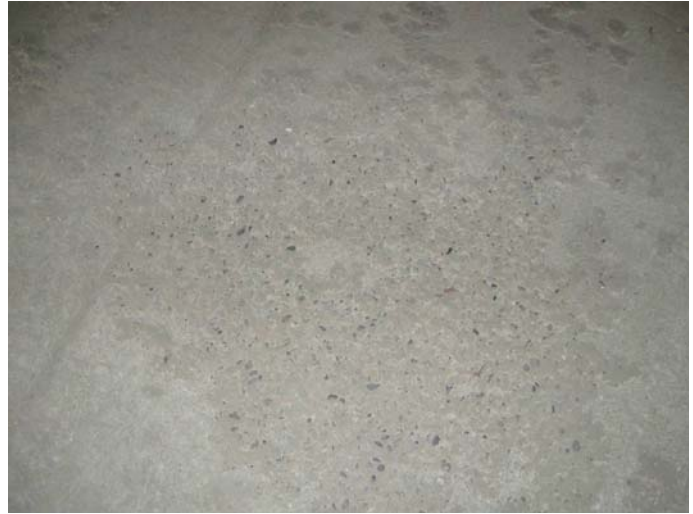
Comp #: 403 Concrete - Repair/Replace

The lower parking structure has some major spalling and cracking that should be addressed in the next year. The other parking structure concrete is in relatively good to fair condition with only some cracking and spalling noted. Since it is unlikely that all concrete surfaces will fail at the same time, we suggest establishing a Reserve fund for periodic repairs and replacement to approximately 25% of the total area (5,400 GSF) every 8 years. Repairs should be coordinated with other concrete surfaces and asphalt for best cost estimate since most asphalt companies can also perform concrete work.

Parking structure upper level - Approx. 7,200 GSF
(Fair condition)
Parking structure lower level - Approx. 14,400 GSF
(Poor Condition with severe spalling/cracking noted)

Best Cost: \$64,800
\$12/GSF; Estimate to replace

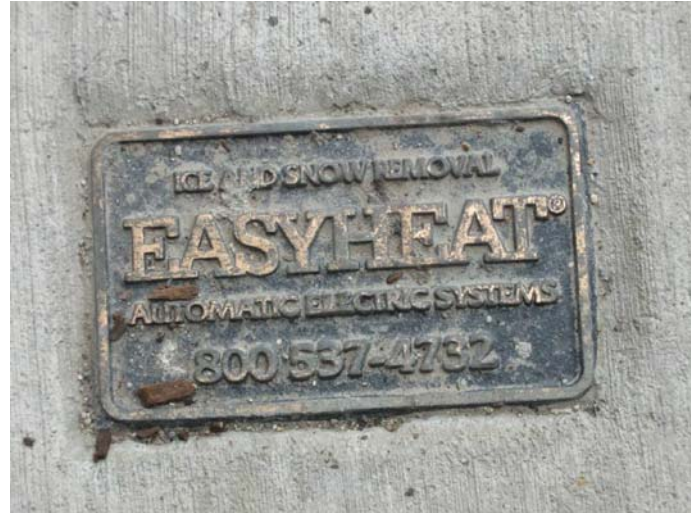
Comp #: 403 Concrete - Repair/Replace

There were signs of moderate cracks and spalling observed at time of inspection. The electric snow melt system for these driveways is reported to be non-operational. It was also reported that when the driveways need to be replaced, the Association will replace the concrete with non-heated concrete. Therefore, at the request of the Association, we have changed the cost basis for this component. Based on the observed levels of cracking, we predict the driveways will need to be replaced within the next 12 - 14 years. Remaining life is based on observed conditions.

NOTE: Concrete is currently heated but non-operational and will be replaced with standard concrete (not heated).

Best Cost: \$65,100
\$12/GSF; Estimate to replace

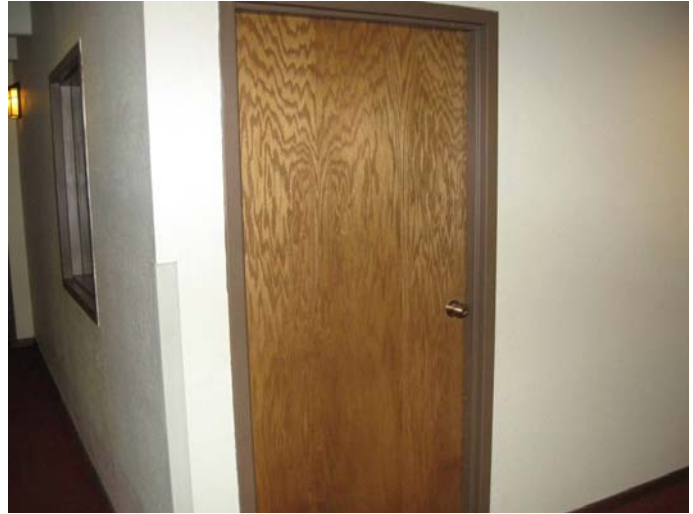
Comp #: 501 Unit Doors (Wood) - Replace

It was reported that the unit front and secondary doors are the responsibility of the individual owners. Therefore, at the request of the Association, Reserve funding has been removed for this component. If the Association should change philosophy on this, Funding can be added in future updates to the report. We recommend establishing a design guideline for replacement to maintain a consistent appearance. The average replacement cycle for entry doors ranges between 15 - 20 years under normal conditions and could cost between \$500 and \$600 per door.

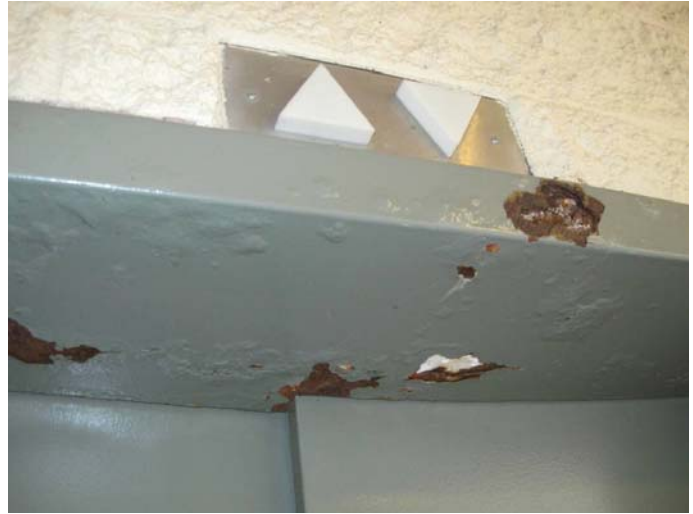
Comp #: 504 Elevator Door Frames - Replace

No problems with the elevator doors noted at the time of inspection. However, there are several exterior elevator door frames that are rusting out and need to be replaced in the next fiscal year. Reserve to replace three (3) door frames every 10 years due to exposure to the elements. Remaining life has been extended based on observed condition.

\$2500/door frame; Estimate to replace frame

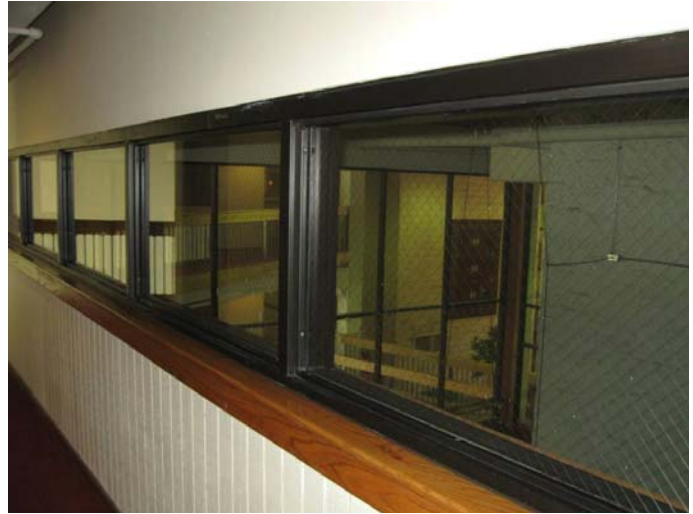
Comp #: 506 Windows/Glass Doors - Replace

Most of these windows are interior and have an extended life. Reglaze glass as needed with operating funds. No Reserve funding required at this time.

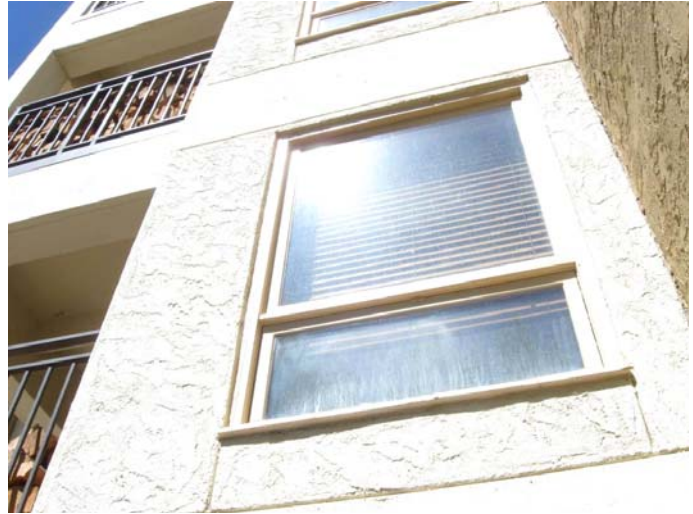
Comp #: 506 Unit Windows/Sliding Glass Doors - Replace

It was reported that the Association has determined that window and sliding glass door replacement will be the responsibility of the individual unit owner. We suggest establishing a design guideline for window replacement to maintain consistency throughout the building.

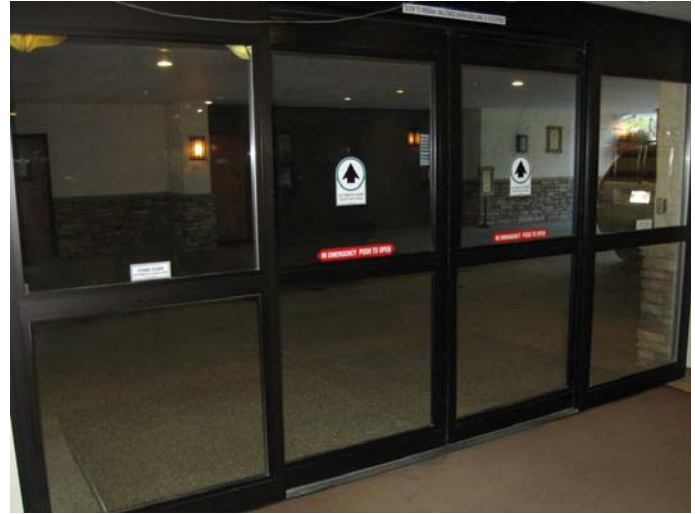
Comp #: 507 Automatic Sliding Glass Doors - Replace

The glass doors will have an extended life expectancy and can be re-glazed as needed with operating funds. Reserve funding is to replace the "guts" of the system only. Remaining life is based on observations and current operation of the door. Service the door with operating funds as needed.

\$3000/door unit; Estimate to replace mechanism only

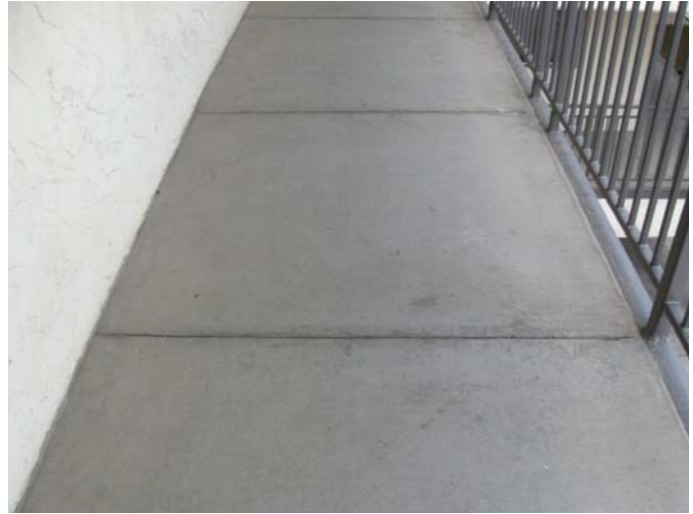
Comp #: 601 Concrete Sidewalks/Decks - Repair

While it is unlikely that all concrete surfaces will fail and need to be replaced at the same time, frequent repairs and replacement to a percentage of the area (15% or 1850 GSF), should be anticipated every 4 years.

Stairwells - 136 GSF (landing)
Building stairwells - 504 GSF (landings)
4th floor (12 units outdoor) - 2,476 GSF
5th floor (12 units outdoor) - 2,476 GSF (some cracking, minor spalling)
6th floor (4 units outdoor) - 863 GSF (cracking & spalling)
(56) Unit decks - 5,880 GSF (7x15)

Allowance to repair 10% of area every 4 years

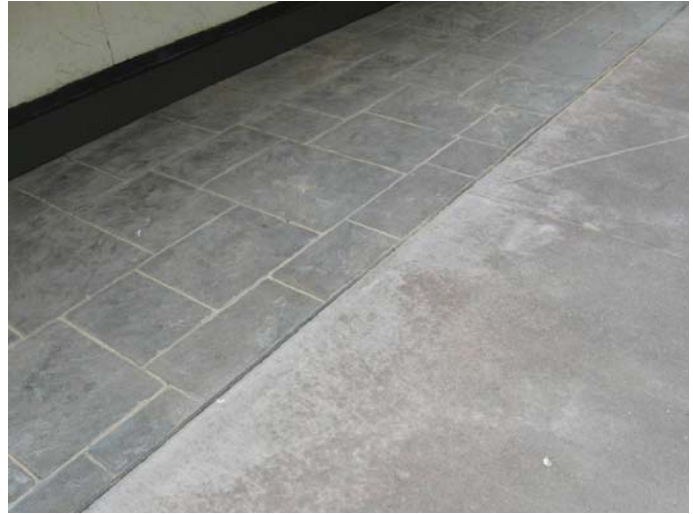
Comp #: 603 Stamped Concrete - Repair/Replace

The concrete is brand new as part of the 3rd level courtyard refurbishment project. Expect to make repairs to concrete approximately every 10 years to maintain appearance. Remaining life based on current condition. This component is also part of the 3rd level remodel component #2020 to be replaced every 30 years. Amount will remain as a cushion for possible additional costs.

Allowance for repairs

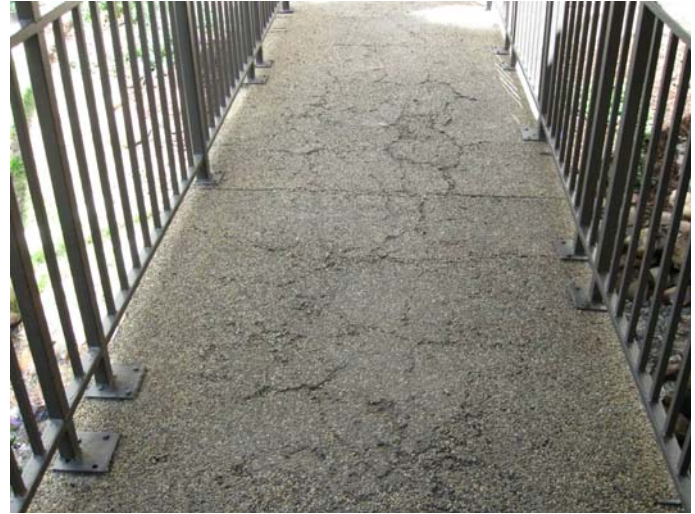
Comp #: 605 Everstone Coated Concrete - Repair/seal

The Everstone decking is an exposed aggregate product that is set in a resin-type material and is designed to cover an existing concrete surface. The Association should plan to repair and reseal these surfaces every 2 - 3 years based on exposure to the elements and level of use. The protected surfaces should expect a longer useful life than the exposed surfaces.

Everstone concrete:
Lobby Entry - 586 GSF
Parking garage level - 776 GSF (cracking & some loose material)
Lower deck - 2,802 GSF (cracking & some loose material)

Estimate to repair and reseal

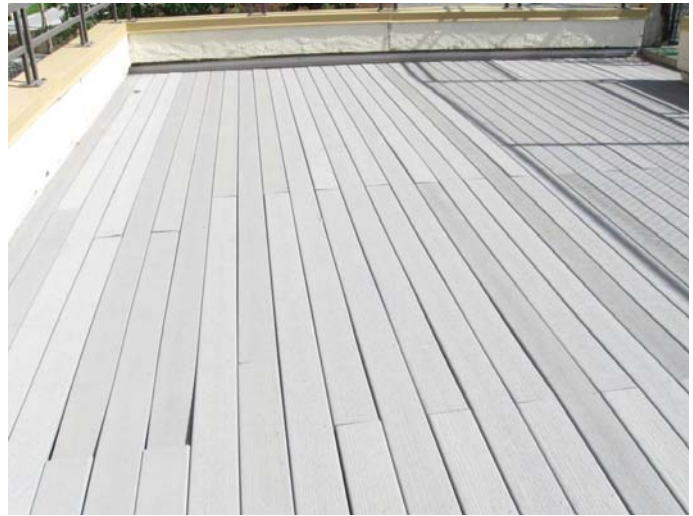
Comp #: 609 Composite Deck - Replace

The composite deck is new within the past few years but the conditions vary from good to poor condition (see General Notes). Most composite deck manufacturers offer a 25 year limited warranty from against defects. However, over a period of time, the material begins to fade and scratch and eventually will become aesthetically displeasing. Therefore, due to the level of use and exposure to the elements, we recommend establishing a replacement cycle of 18 - 20 years. Remaining life is based on age of deck and observed conditions.

Upper deck has some broken pieces & staining from restaurant.

Upper tennis court deck was poorly installed and has settling boards. This should be repaired immediately as it is presenting a safety concern.

Estimate to replace decking only

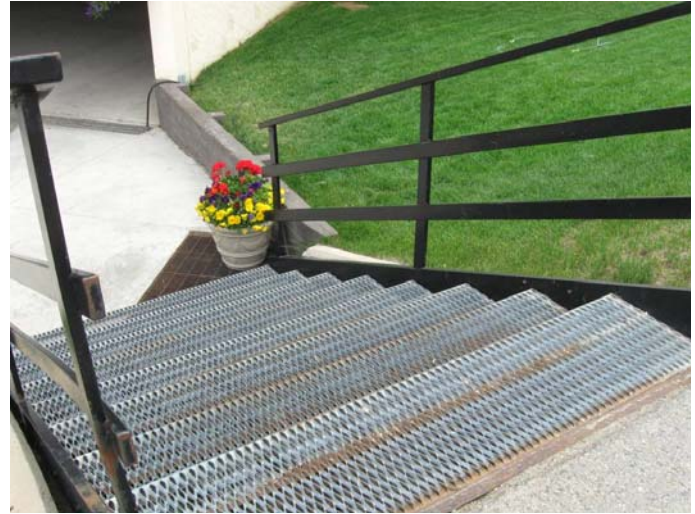
Comp #: 610 Steel Stairs - Replace

Most of the stair sets are in good condition with the exception of the stair leading to the upper Crested Butte parking lot. This set appears to receive more use and abuse than the other locations but it was reported that the Association is responsible for it even though it is not directly on the property. These stair sets have an extended life and it was reported that the stairs will be replaced as needed as an operating expense. Reserve funding is not appropriate at this time.

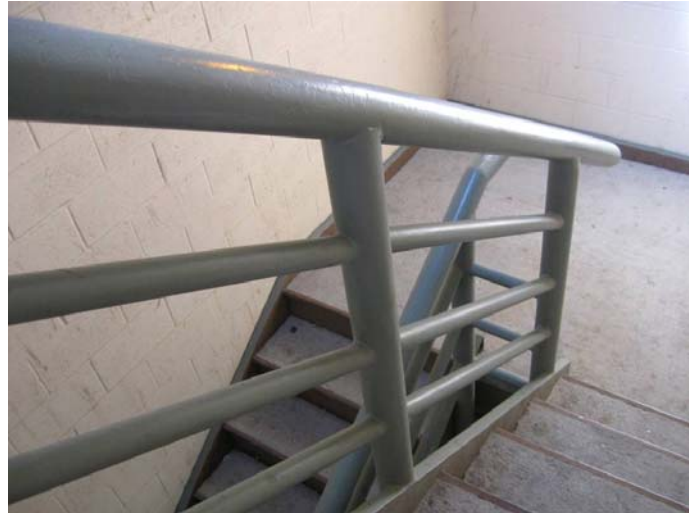
Comp #: 610 Concrete Stairs - Replace

These stair treads are original and protected from the elements. Make local repairs as necessary with operating funds. No Reserve funding required for this component

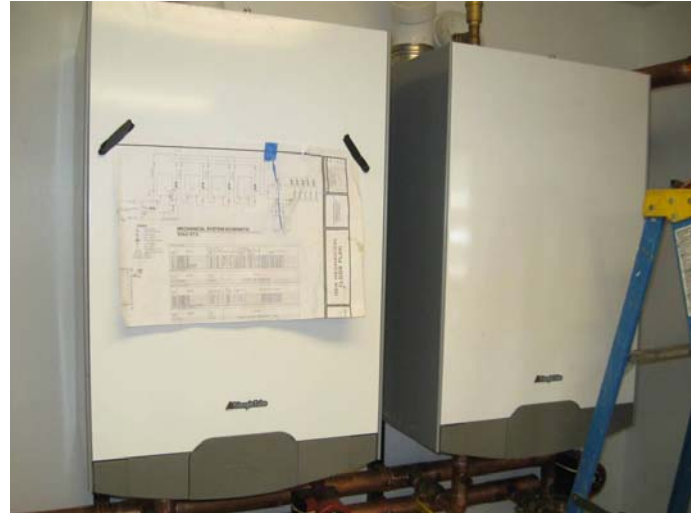
Comp #: 701 Boilers - Major Repairs

These boilers were install in 2010 and are for the snow melt system installed for the third level renovation project. Due to the expected level of use these systems will receive, major renovations will need to occur every 8 - 10 years. According to manufacturer, these units typically do not require complete replacement. However, parts eventually become obsolete after numerous years and with advances in technology, replacement may become necessary at some point in the next 30+ years. This line item is for major rebuilding of boiler components every 10 years. See item #702 for replacement.

Best Cost: \$4,000
\$1000/Boiler; Estimate to replace

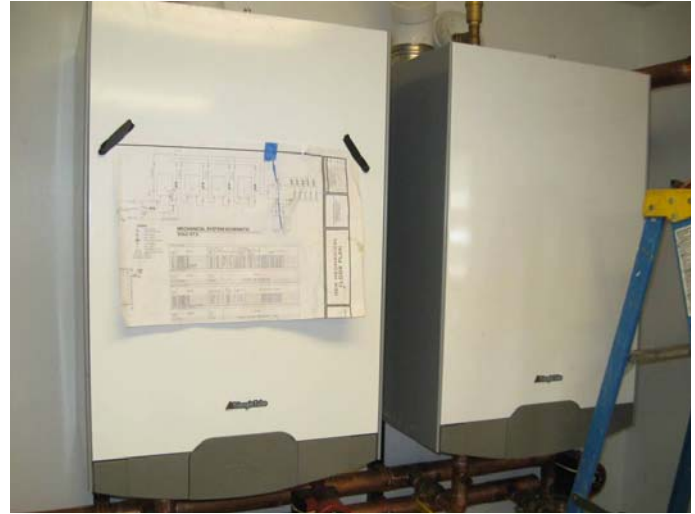
Comp #: 702 Boilers - Replace

These boilers were install in 2010 and are for the snow melt system installed for the third level renovation project. Due to the expected level of use these systems will receive, major repairs will need to occur every 8 - 10 years. This component is included with the 3rd level remodel component #2020 and remains as a reference item only at this time.

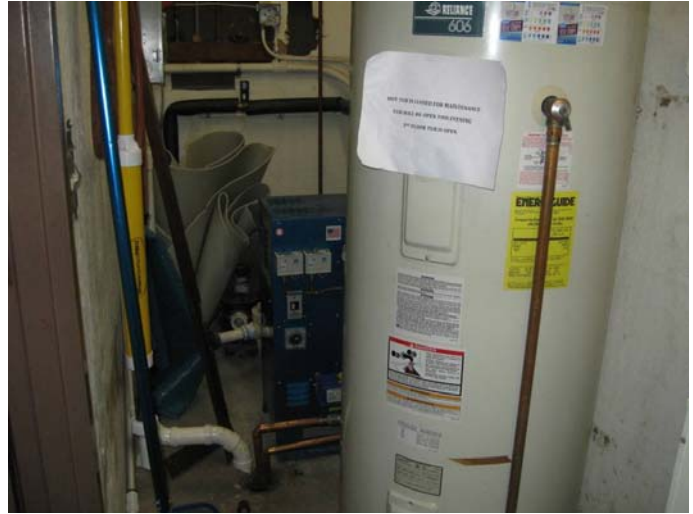
Comp #: 703 Hot Water Heater Tank - Replace

Heater is generally in good condition. No problems noted at the time of inspection. Expect a useful life of approximately 12 - 15 years from this component. Remaining life based on current condition.

\$2000/heater; Estimate to replace

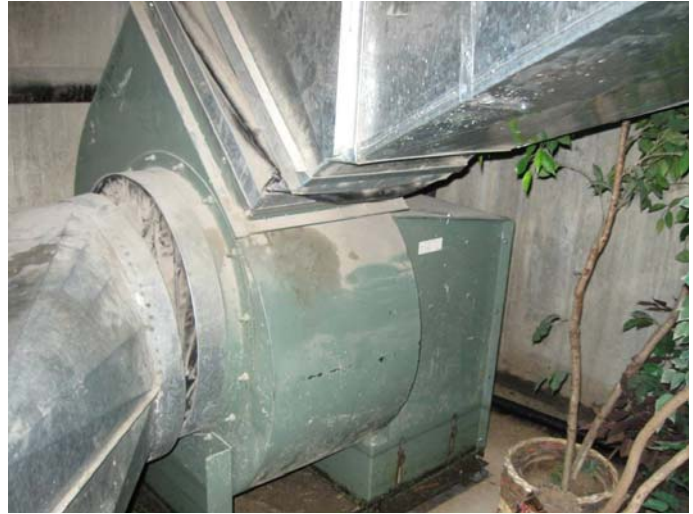
Comp #: 706 Duct Heaters - Replace

Furnace is in good condition, no problems noted at the time of inspection. Reserve to rebuild every 15 - 18 years.

\$6000/heater; Higher estimate for more repairs

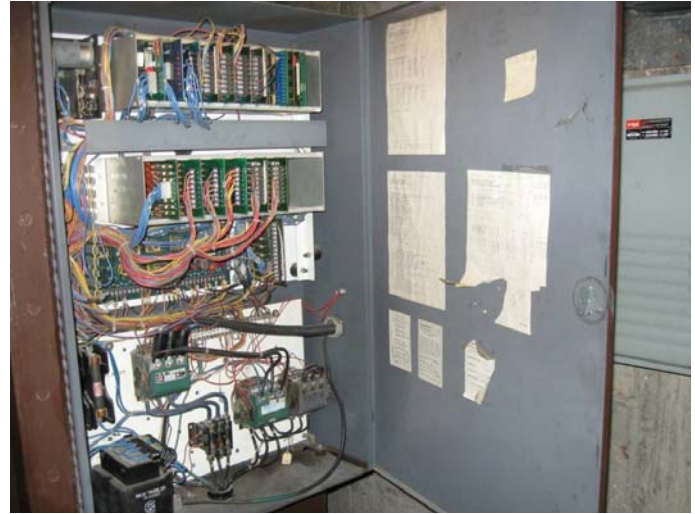
Comp #: 707 Elevator - Rebuild/Upgrade

No problems noted or reported at the time of inspection. Approximately every 24 to 26 years expect to make significant upgrades and replacements to elevator controller and door packages. It was reported that a major elevator over hall is scheduled for the 2014/2015 fiscal year. Remaining life based on this scheduled date.

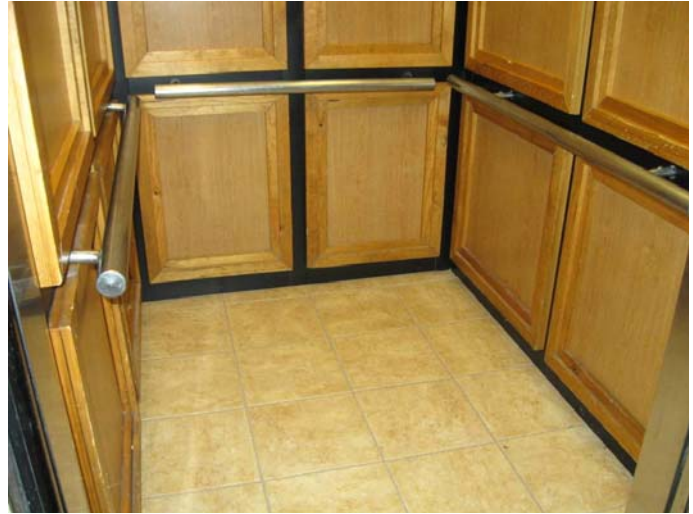
Comp #: 709 Elevator Cab - Remodel

Elevator cabs are in fair condition. Minor scuffing and marking noted on elevator walls along with damage on the door in Elevator #2. Expect to remodel cab approximately every 12 - 13 years to maintain appearance and keep up with current decorative tastes. NOTE: The elevator door frames are rusted out on several floors and should be replaced. Remaining life based on observed conditions.

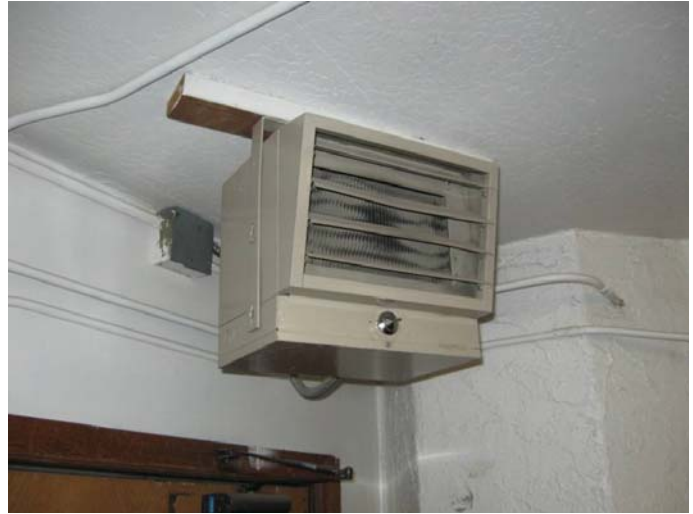
Comp #: 717 Suspended Heaters - Replace

Due to the relatively low cost of this heater, replace as needed with operating funds. No Reserve funding required at this time.

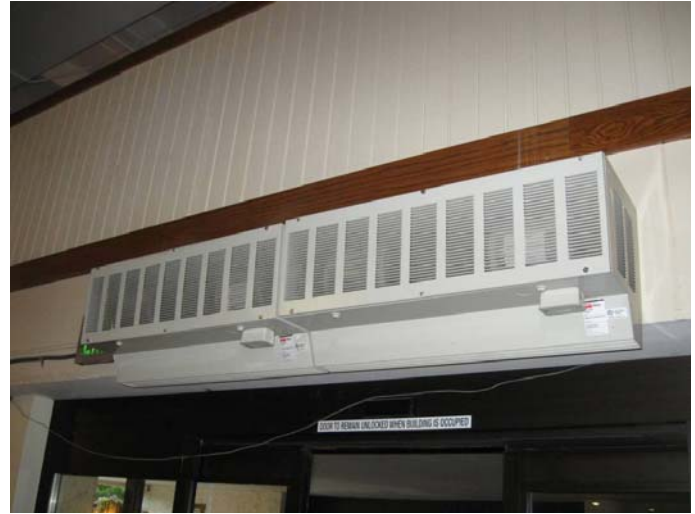
Comp #: 725 Automatic Heaters - Replace

Heaters were not operational at the time of inspection due to the property observation being conducted during the summer months. There were no reports of problems with the heater. Maintenance and replacement costs should be handled as an operating expense.

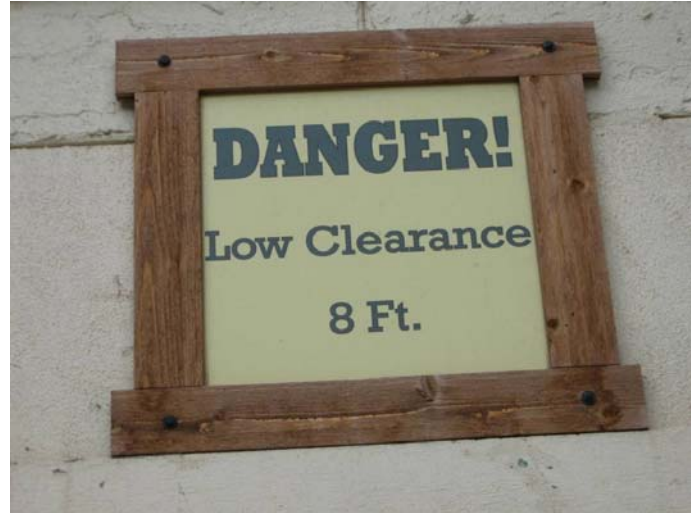
Comp #: 808 Street Signs - Replace

All signs were legible and in good condition at time of inspection. While all signs are functional, over a period of time, decorative tastes change and replacement will become necessary. On average, Associations in this type of environment (Mountain Lodges) typically upgrade their signs every 12 - 15 years. Therefore, we have established a Reserve line item for periodic replacement of signs every 15 years based on the observed condition and assumed age of these signs.

Allowance to replace signs
