Plaza Condominiums
11 Snowmass Road
Mt. Crested Butte, CO 81225

Level 1 Reserve Analysis

Report Period – 01/01/11 – 12/31/11

Date of Property Observation - July 15, 2010
Project Manager - Steve Kelsen
Main Contact Person - Mr. Eli Haine, Community Manager

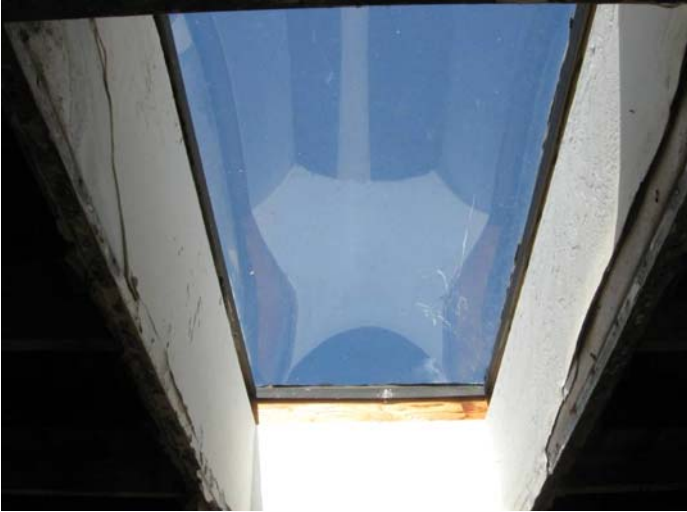
Comp #: 123 Skylights - Replace

It appeared that there was some possible leaking around the skylight by evidence that the drywall in the stairwell ceiling had been removed and rusting around the edges of the skylight. It was reported that there are plans to completely remove the skylight in the near future, therefore, funding for future replacement has been removed at the request of the Association.

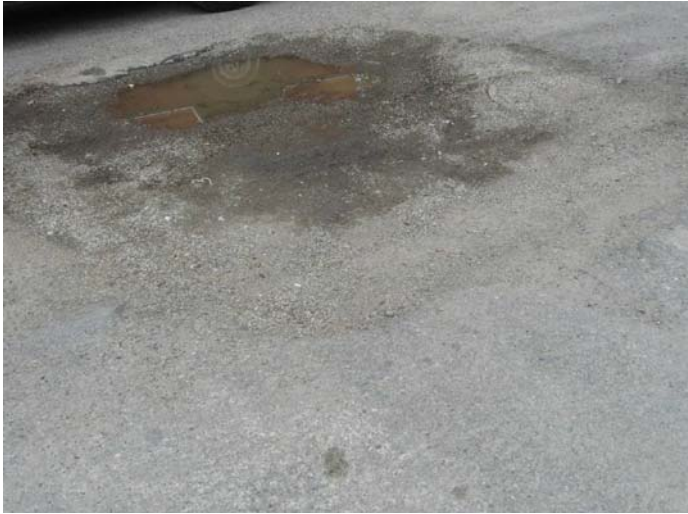
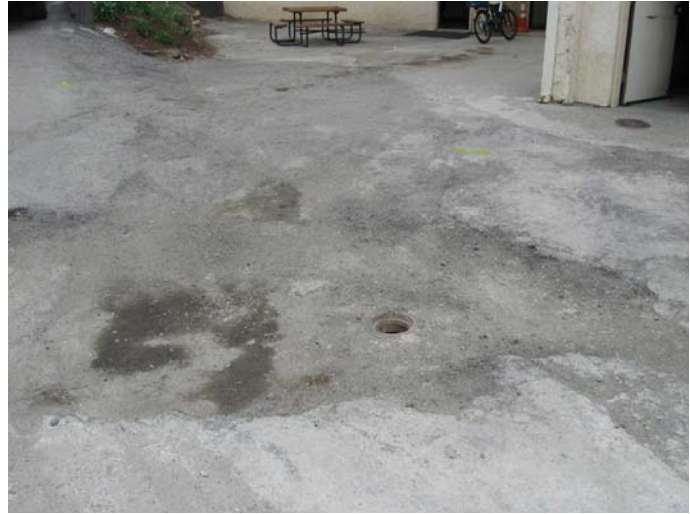
Comp #: 401 Asphalt (1b) - Overlay

The lower maintenance drive and lower parking garage entrance is in poor condition with severe pot holes significant loss of material. It was reported that based on the "Six Year Capital Plan" established by the Association, the asphalt in this area will be replaced this coming 2010/2011 fiscal year. The average life expectancy for asphalt surfaces in this environment ranges between 13 - 17 years for surfaces that are maintained on a regular schedule. Maintenance includes crack fill and repairing small potholes annually as an operating expense. In addition, asphalt in this environment should be seal coated every 2 -3 years. Remaining life is based on the observed conditions and the plan.

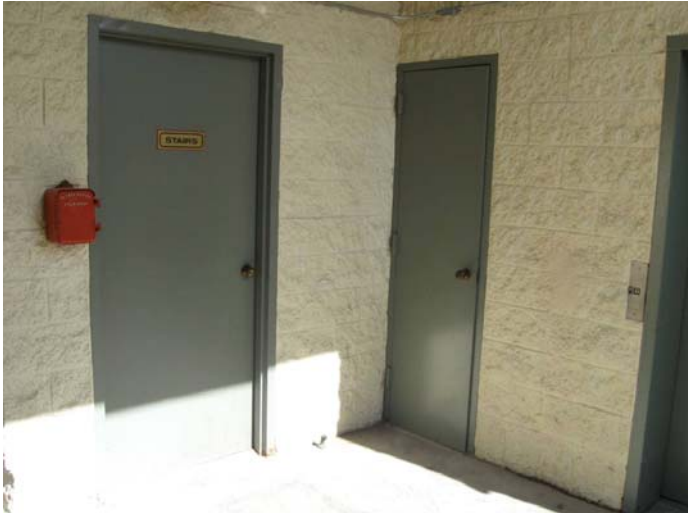
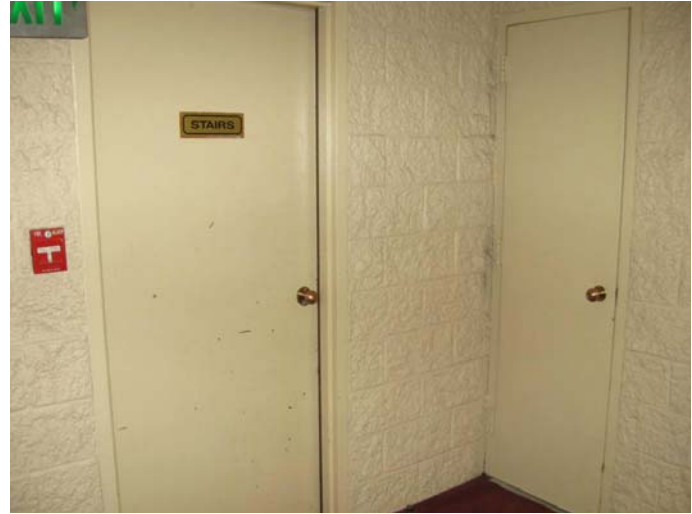
Comp #: 503 Utility doors - Replace

No problems with the doors noted at the time of inspection. Expect to replace these doors approximately every 20 years. Remaining life has been extended based observed condition.

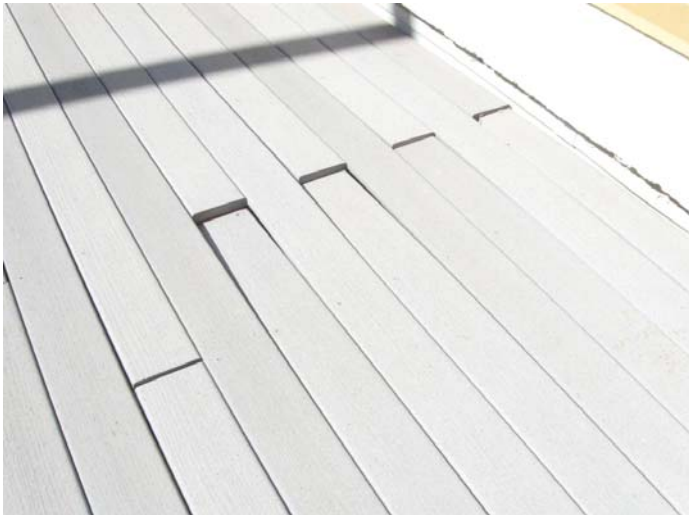
Comp #: 609 Composite Deck - Replace

The composite deck is new within the past few years but the conditions vary from good to poor condition (see General Notes). Most composite deck manufacturers offer a 25 year limited warranty from against defects. However, over a period of time, the material begins to fade and scratch and eventually will become aesthetically displeasing. Therefore, due to the level of use and exposure to the elements, we recommend establishing a replacement cycle of 18 - 20 years. Remaining life is based on age of deck and observed conditions.

Upper deck has some broken pieces & staining from restaurant.

Upper tennis court deck was poorly installed and has settling boards. This should be repaired immediately as it is presenting a safety concern.

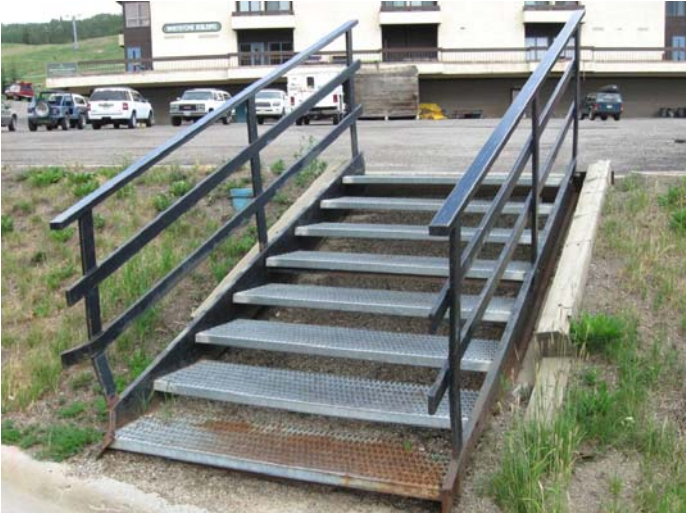
Comp #: 610 Steel Stairs - Replace

Most of the stair sets are in good condition with the exception of the stair leading to the upper Crested Butte parking lot. This set appears to receive more use and abuse than the other locations but it was reported that the Association is responsible for it even though it is not directly on the property. These stair sets have an extended life and it was reported that the stairs will be replaced as needed as an operating expense. Reserve funding is not appropriate at this time.

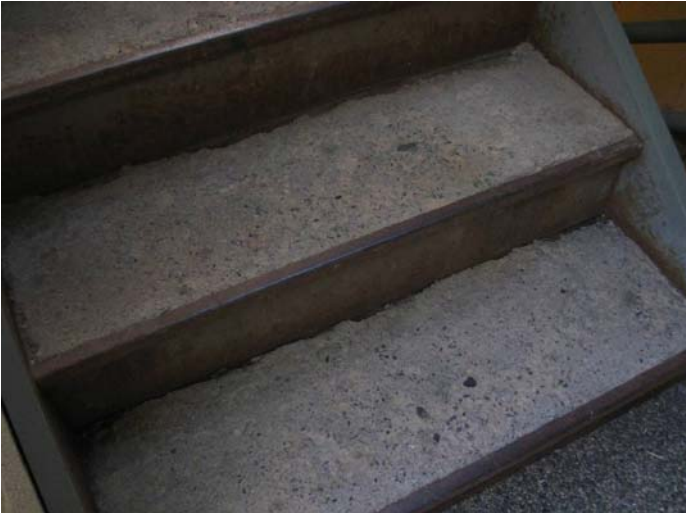
Comp #: 610 Concrete Stairs - Replace

These stair treads are original and protected from the elements. Make local repairs as necessary with operating funds. No Reserve funding required for this component

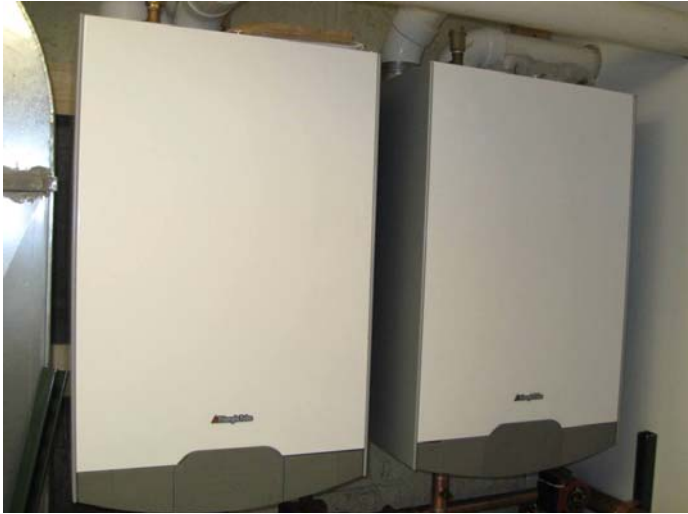
Comp #: 701 Boilers - Major Repairs

These boilers were install in 2010 and are for the snow melt system installed for the third level renovation project. Due to the expected level of use these systems will receive, major renovations will need to occur every 8 - 10 years. According to manufacturer, these units typically do not require complete replacement. However, parts eventually become obsolete after numerous years and with advances in technology, replacement may become necessary at some point in the next 30+ years. This line item is for major rebuilding of boiler components every 10 years. See item #702 for replacement.

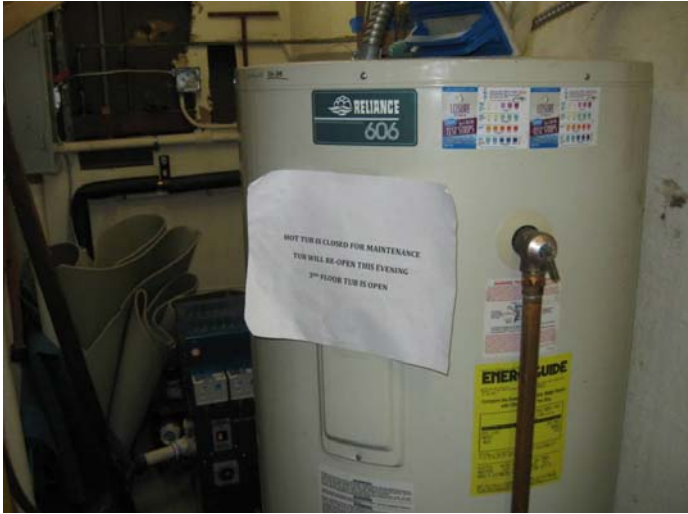
Comp #: 703 Hot Water Heater Tank - Replace

Heater is generally in good condition. No problems noted at the time of inspection. Expect a useful life of approximately 12 - 15 years from this component. Remaining life based on current condition.

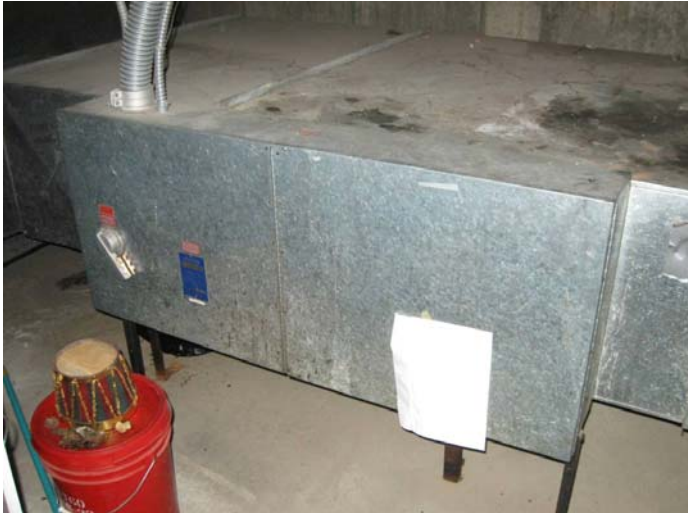
Comp #: 706 Duct Heaters - Replace

Furnace is in good condition, no problems noted at the time of inspection. Reserve to rebuild every 15 - 18 years.

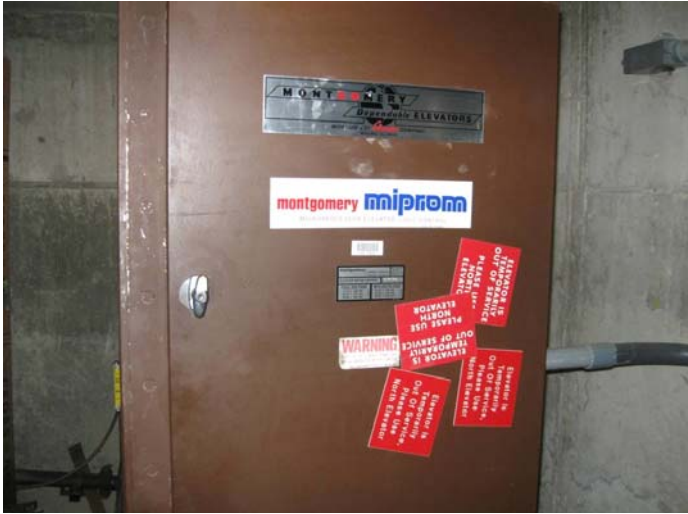
Comp #: 707 Elevator - Rebuild/Upgrade

No problems noted or reported at the time of inspection. Approximately every 24 to 26 years expect to make significant upgrades and replacements to elevator controller and door packages. It was reported that a major elevator over hall is scheduled for the 2014/2015 fiscal year. Remaining life based on this scheduled date.

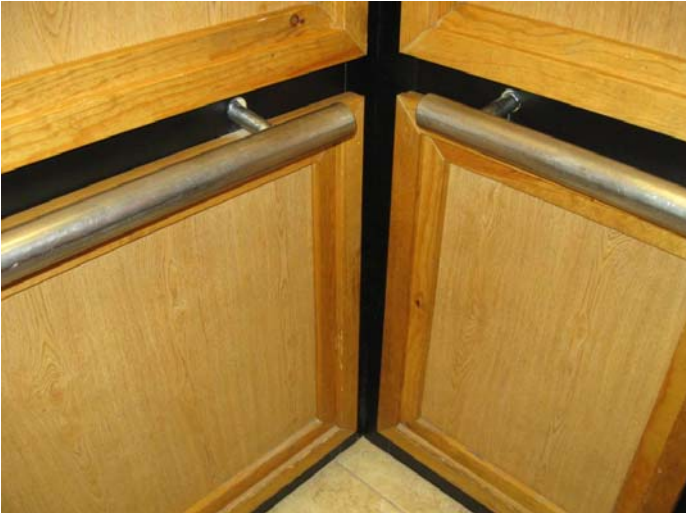
Comp #: 709 Elevator Cab - Remodel

Elevator cabs are in fair condition. Minor scuffing and marking noted on elevator walls along with damage on the door in Elevator #2. Expect to remodel cab approximately every 12 - 13 years to maintain appearance and keep up with current decorative tastes. NOTE: The elevator door frames are rusted out on several floors and should be replaced. Remaining life based on observed conditions.

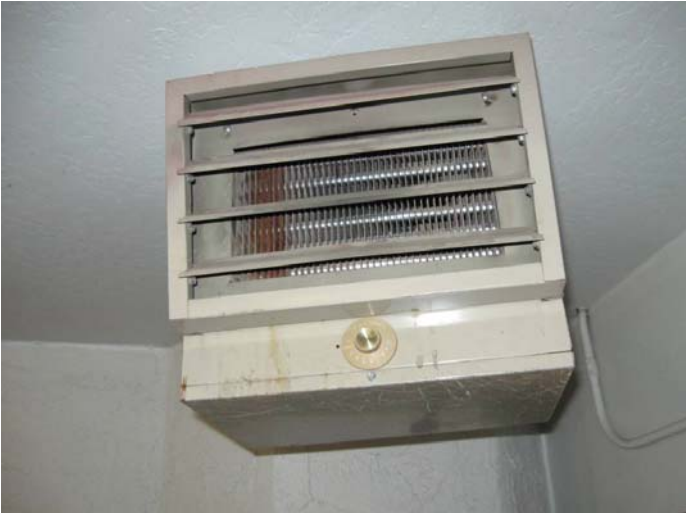
Comp #: 717 Suspended Heaters - Replace

Due to the relatively low cost of this heater, replace as needed with operating funds. No Reserve funding required at this time.

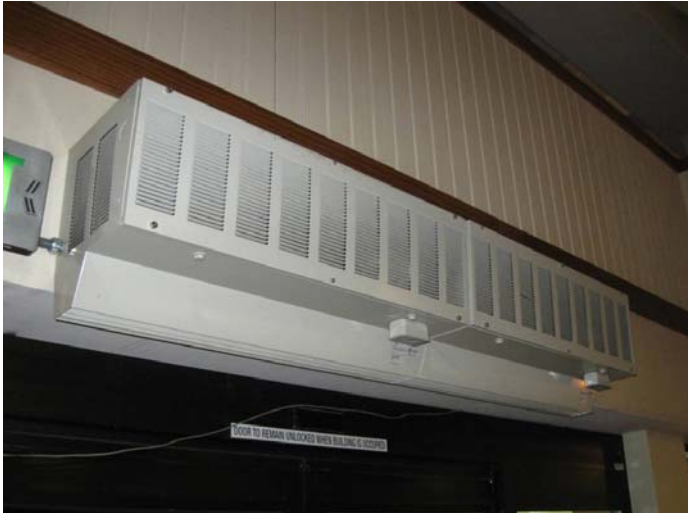
Comp #: 725 Automatic Heaters - Replace

Heaters were not operational at the time of inspection due to the property observation being conducted during the summer months. There were no reports of problems with the heater. Maintenance and replacement costs should be handled as an operating expense.

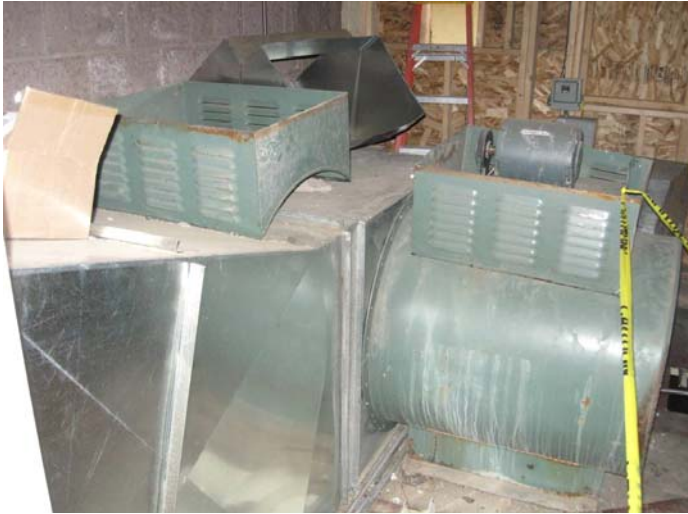
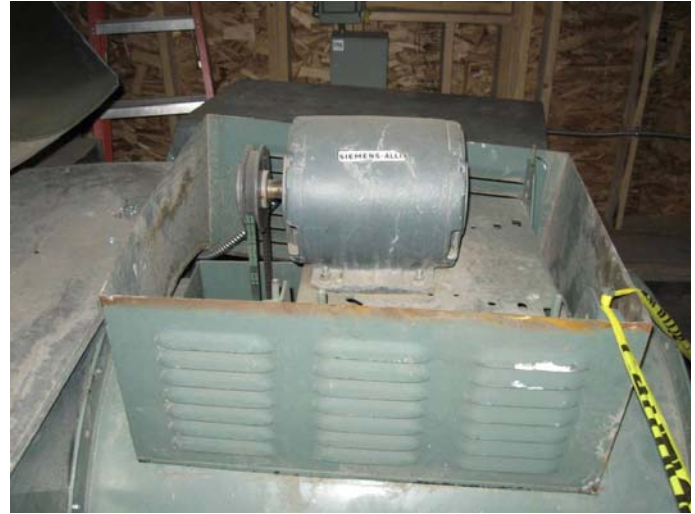
Comp #: 729 Smoke Extraction System - Replace

The systems are original and are only used in the event of an emergency. The systems are tested twice a year. Annual maintenance should be handled as an operating expense after testing of the systems. No Reserve funding is required at this time.

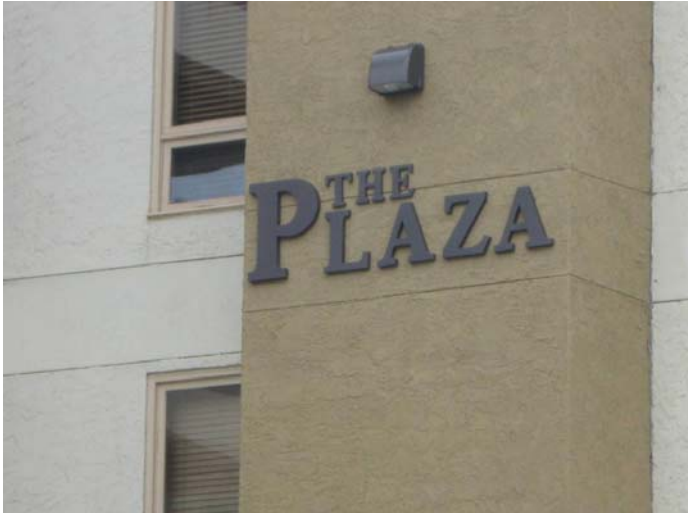
Comp #: 808 Street Signs - Replace

All signs were legible and in good condition at time of inspection. While all signs are functional, over a period of time, decorative tastes change and replacement will become necessary. On average, Associations in this type of environment (Mountain Lodges) typically upgrade their signs every 12 - 15 years. Therefore, we have established a Reserve line item for periodic replacement of signs every 15 years based on the observed condition and assumed age of these signs.

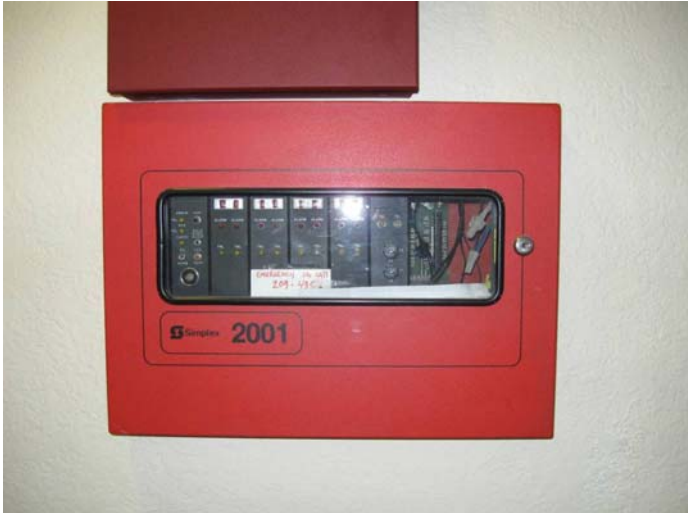
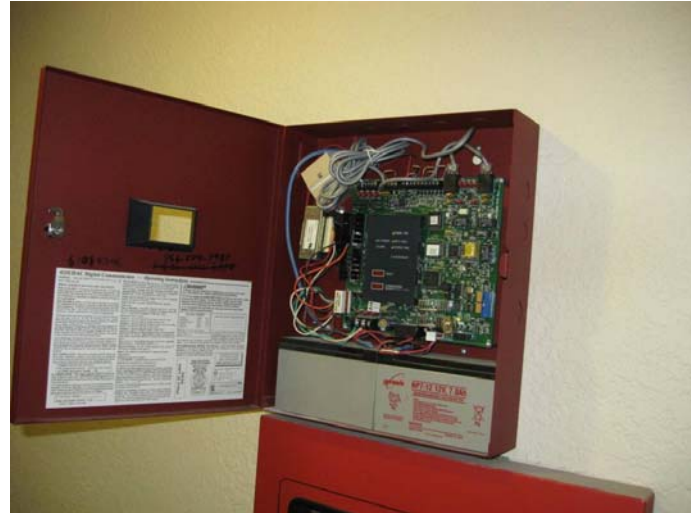
Comp #: 901 Fire Protection System - Replace

Reported that fire protection system is functioning normally and is in good condition. Expect to make regular repairs and individual component replacements as an operating expense and to significantly upgrade system approximately every 15 years. Remaining life based on current age.

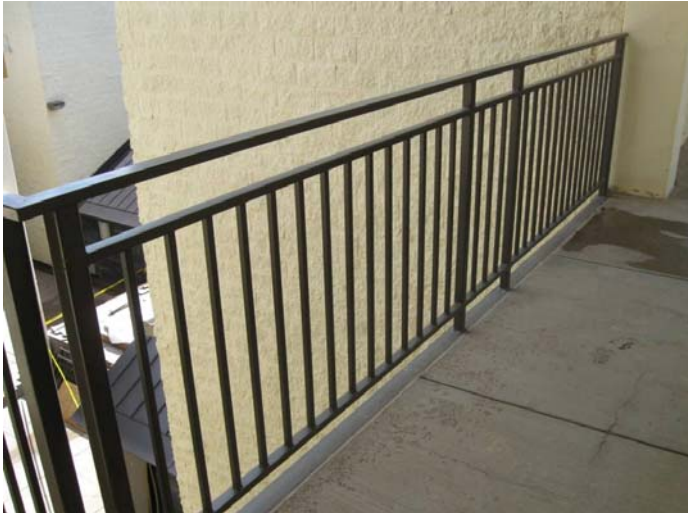
Comp #: 1002 Metal Railing - Replace

It was reported that the iron railing were replace in the 2009/2010 fiscal year. The fence is in good condition with no structural problems observed. The average replacement cycle for this type of fencing typically ranges between 25 - 35 years, depending on maintenance levels and exposure to elements. Remaining life is based on age of the rail.

Metal railing - 418 LF
 B parking lot - 24 LF (needs paint, rust showing)
 Lobby from street - 13 LF (better condition, needs paint)
 Stairwells - 147 LF (steel tube, painted)
 Building stairwells - 822 LF painted; 280 LF single tube
 Parking structure upper level - 578 LF
 1st floor (6 units) - 95 LF
 2nd floor (12 units) - 128 LF (natural steel)
 Courtyard - 17 LF (not installed)
 Courtyard hot tub - 98 LF (not installed)
 4th floor (12 units outdoor) - 465 LF (fading & rusting)
 5th floor (12 units outdoor) - 465 LF; 2 gates
 6th floor (4 units outdoor) - 204 LF; 2 gates
 (56) Unit deck railings - 1,120 LF x 3'

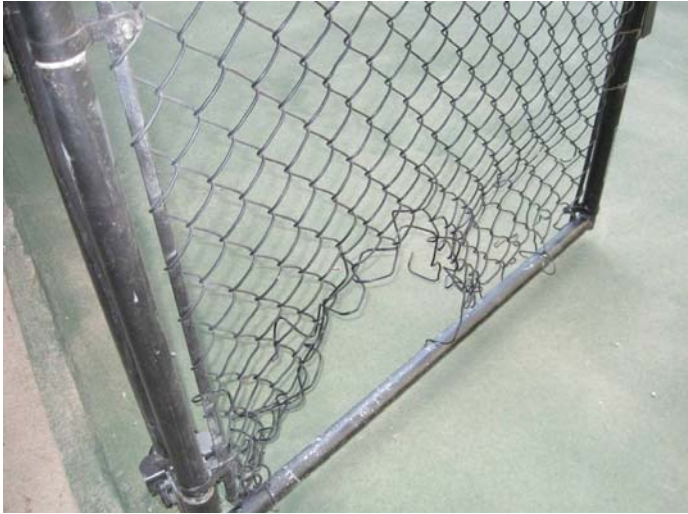
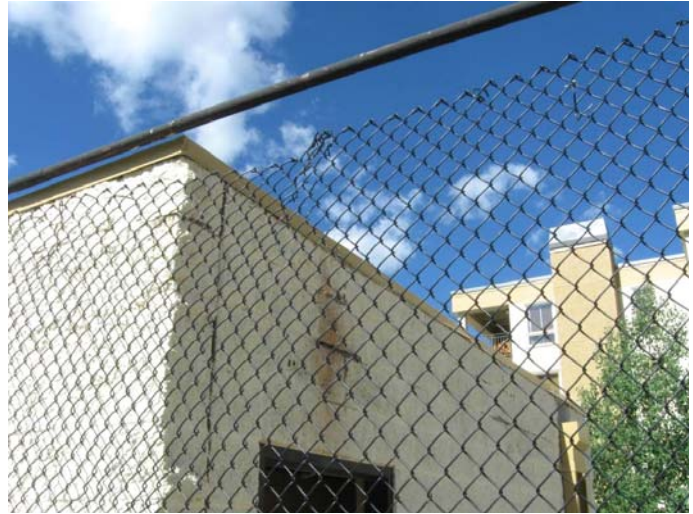
Comp #: 1003 Chain Link Fencing - Replace

The chain link fence surrounding the tennis courts is generally in good to fair condition with some broken areas noted (see General Notes). Local repairs should be completed as part of routine maintenance. Reserve funding has been established to repair 50% (310 LF) of fence line and posts every 15 years. Funding is for replacing mesh only. Post repairs/replacement generally cost approximately \$50 - \$60 per post. Remaining life is based on observed conditions.

NOTE: Needs paint & reattachment at top rail. Damaged gate on lower court.

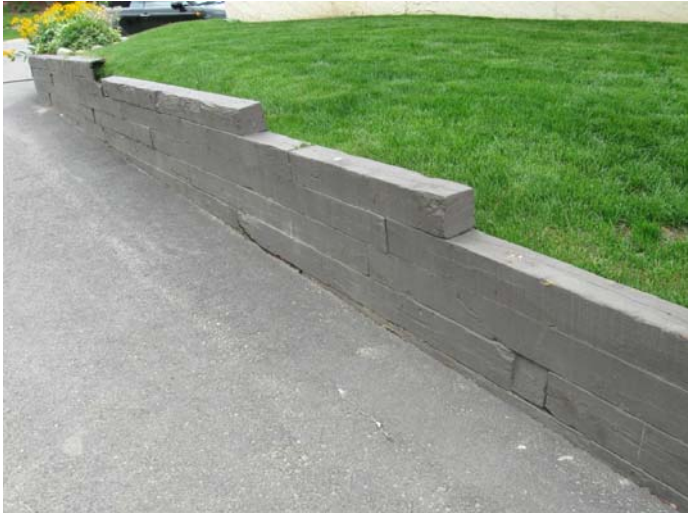
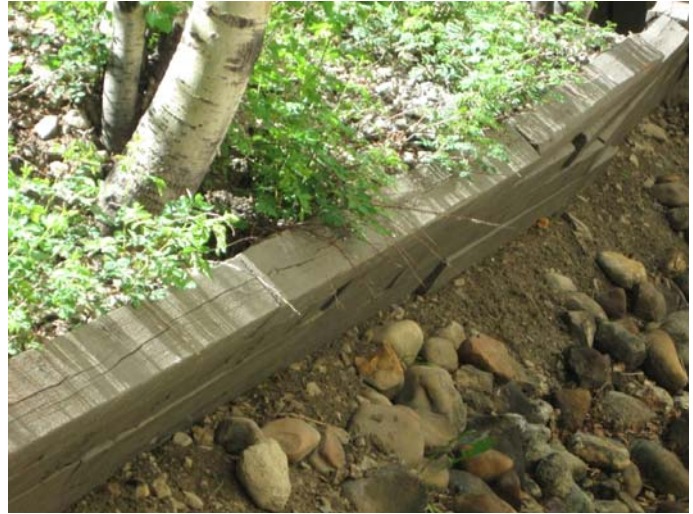
Comp #: 1011 Timber Retaining Wall - Replace

Landscape timbers are in fair to poor condition with signs of rot or deterioration. The wall along the creek is in very poor condition and is severely leaning. It was reported that this section will be replaced in the 2013/2014 fiscal years. Generally, in most conditions, these walls have an overall life expectancy of 20 - 25 years. However, with periodic repairs, the life of the wall can be extended. We suggest establishing a Reserve allowance for periodic major repairs and partial replacements (to approximately 25% of total area or 500 GSF) as opposed to complete replacement all at the same time. Remaining life is based on observed conditions and schedule for first replacement cycle.

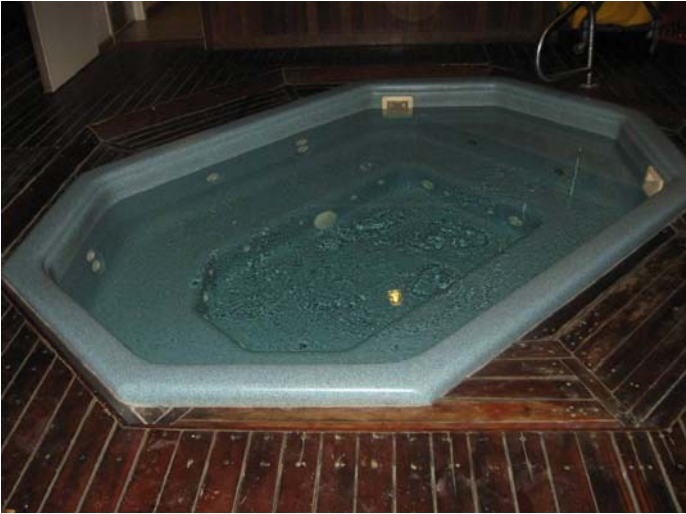
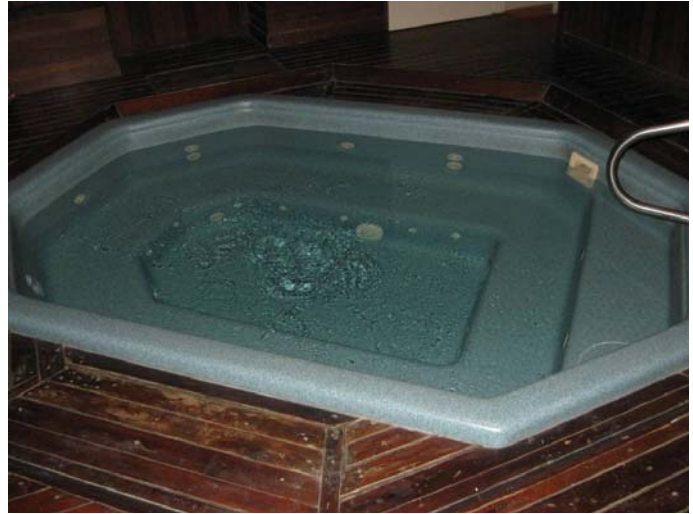
Comp #: 1102 Spa (Indoor) - Replace

Spa is in fair condition. No problems noted at the time of inspection but it was reported that the hot tub is scheduled for replacement as part of the "Six Year Capital Plan" established by the association. Remaining life based on current condition and plan. Coordinate with spa room remodel.

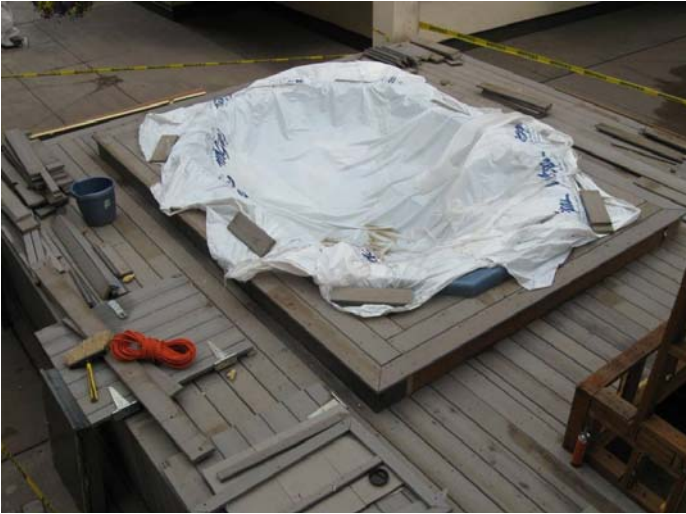
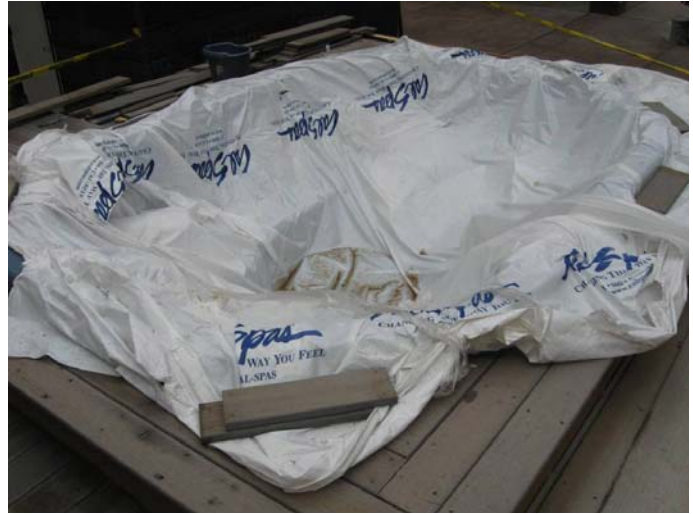
Comp #: 1102 Spa (Outdoor) - Replace

Spa is new but was not operational at the time of the inspection. The hot tub was being replaced as part of the 3rd level renovation project. Remaining life based on age.

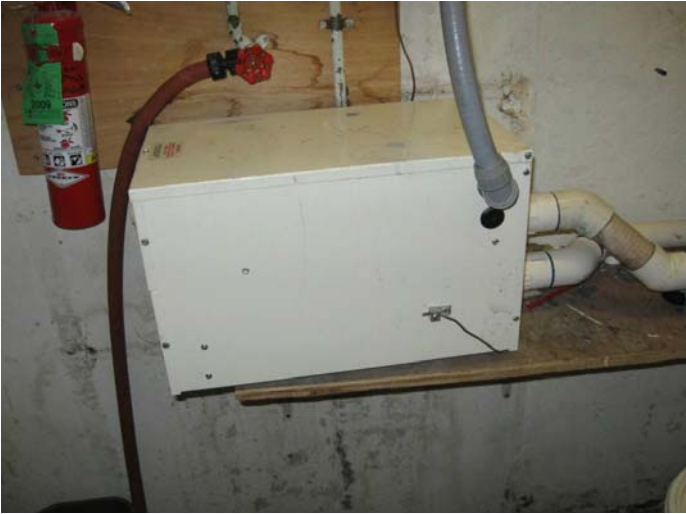
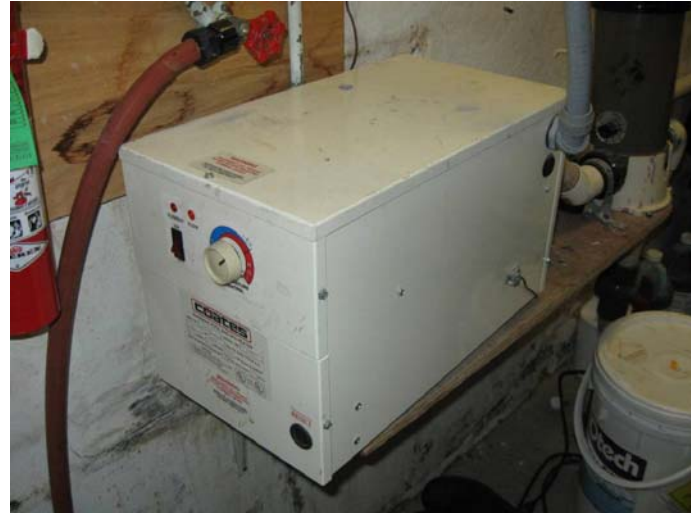
Comp #: 1106 Spa Heater (Indoor) - Replace

The indoor electric spa heater is in good condition. Replacement will be handled as an operating expense. No Reserve funding is included with this component.

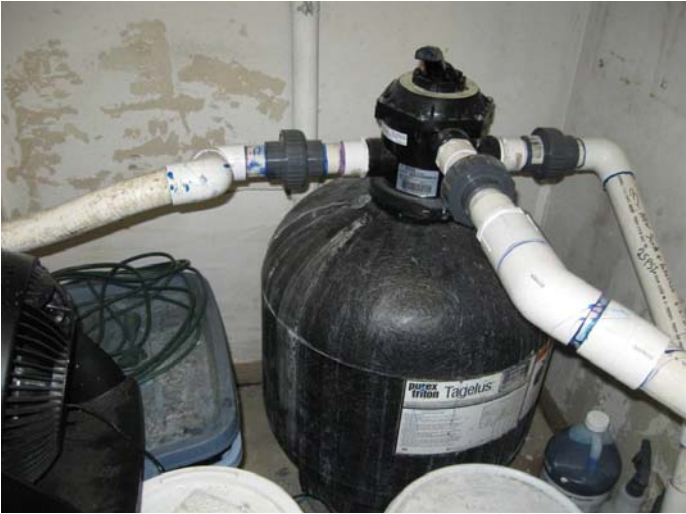
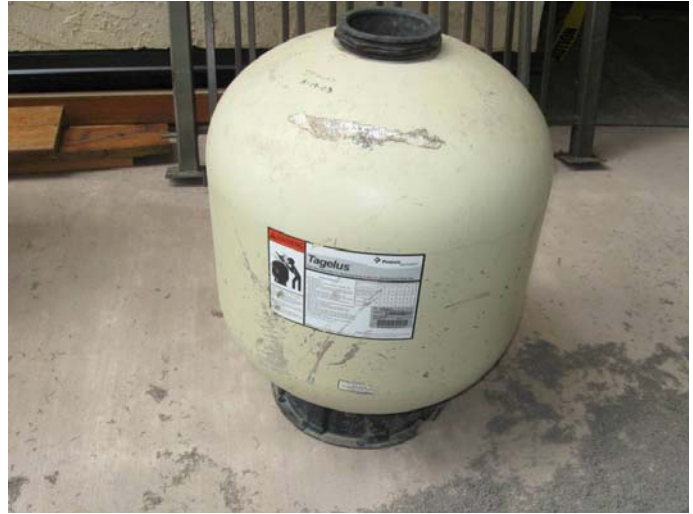
Comp #: 1109 Spa Filter - Replace

Spa filter is in good to fair condition. No evidence of significant leaks or corrosion on the indoor spa filter noted at the time of inspection. The 3rd level spa project was in the progress and was not installed at the time of the inspection. Replacement will be handled as needed as an operating expense.

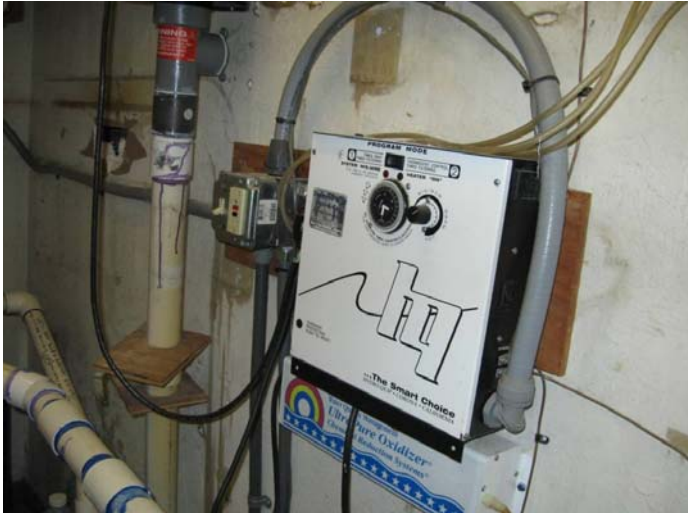
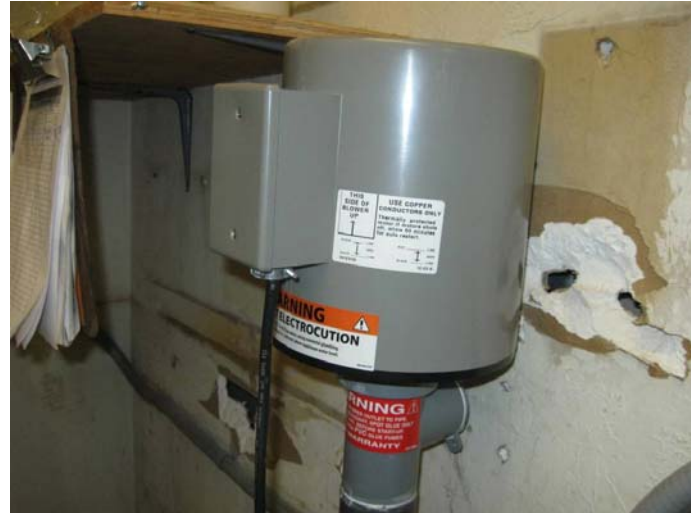
Comp #: 1111 Spa Pumps - Replace

No unusual conditions were observed or reported at time of report preparation. The individual replacement costs of these items is too small for separate Reserve designation. Therefore, we suggest the Association replaced these items on an as needed basis with general operating/maintenance funds.

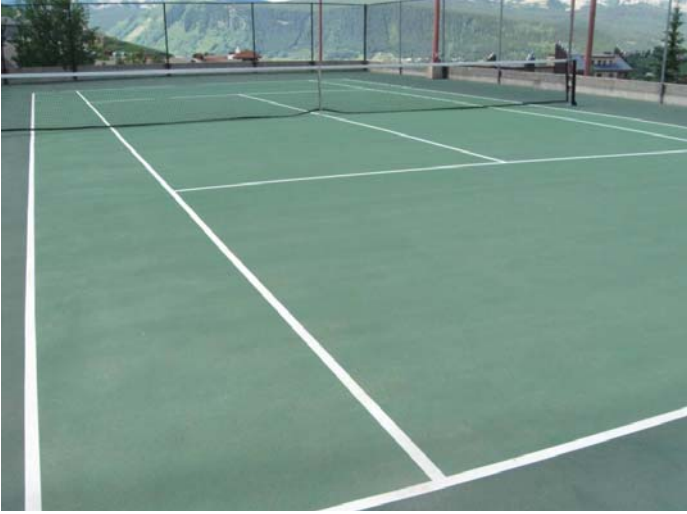
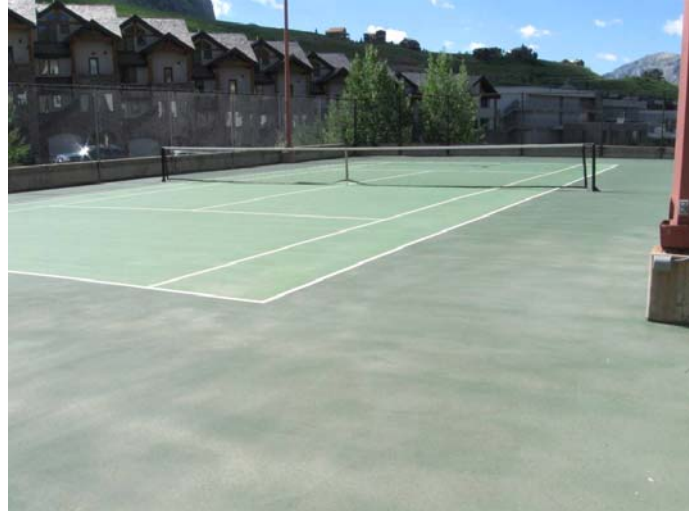
Comp #: 1201 Tennis Court - Resurface

Tennis courts are in good condition. No significant cracking or surface loss noted at the time of inspection. Expect perform minor work to repair low spots and cracks and to resurface/stripe the tennis courts approximately every 6 - 7 years assuming normal use and wear. Remaining life based on current condition and age since the reported last resurface in 2006.

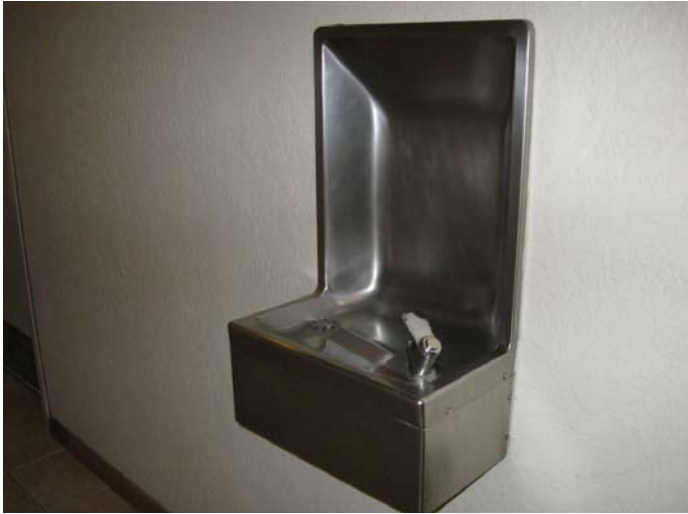
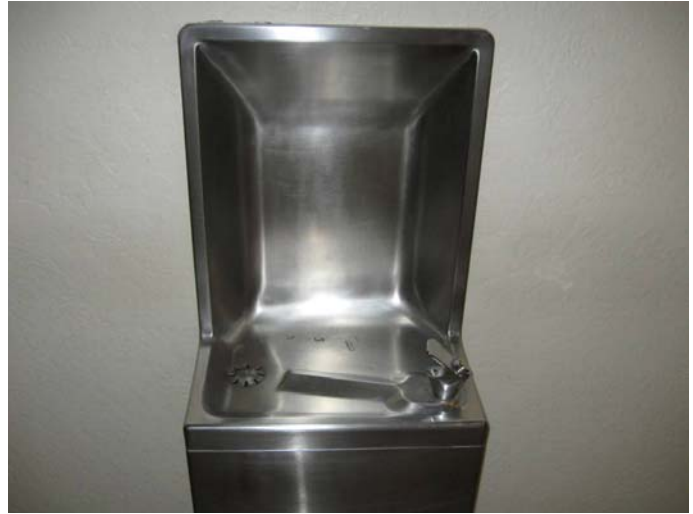
Comp #: 1304 Drinking Fountain - Replace

The drinking fountain is operational and in good condition. Due to the minimal replacement cost (less than \$750) of individual drinking fountains when compared to the life expectancy (10 - 12 years), Reserve funding is not appropriate. Repair and replace drinking fountain as necessary as an operating expense.

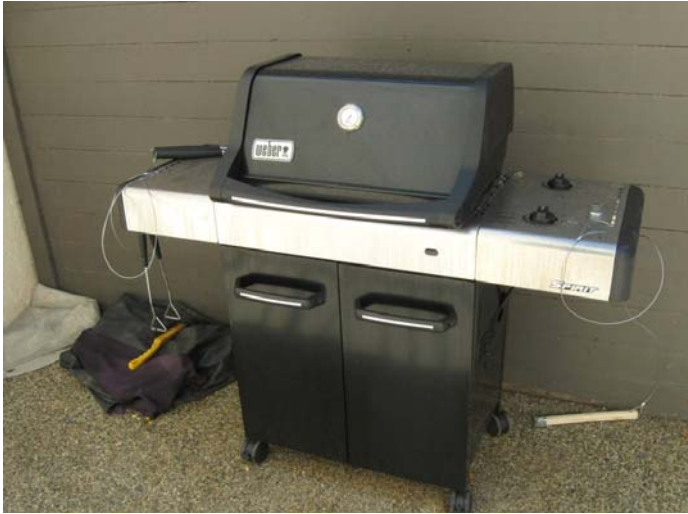
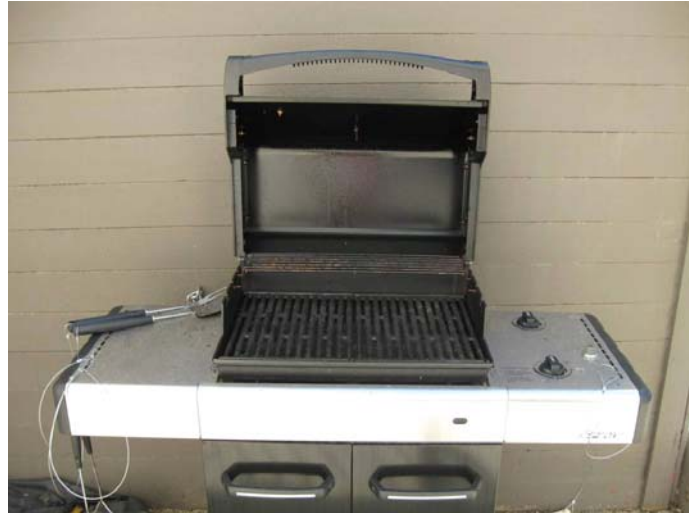
Comp #: 1305 Barbecues - Replace

No problems noted at the time of inspection. Due to the minimal replacement cost associated with this barbecue, Reserve funding is not appropriate. Replace as necessary as an operating expense.

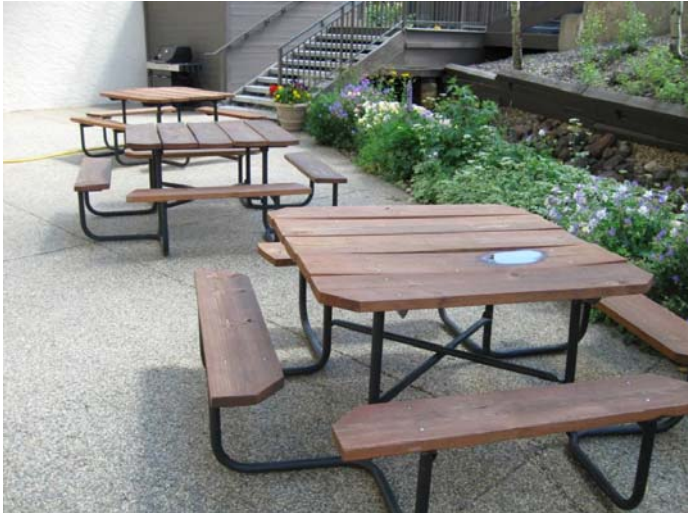
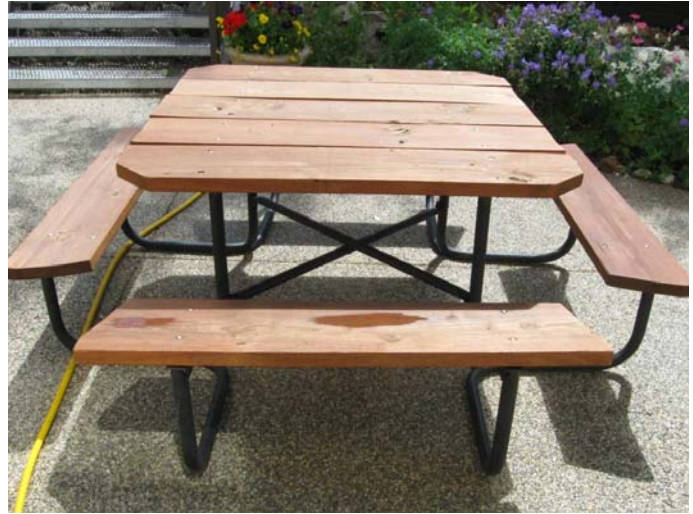
Comp #: 1306 Picnic Tables - Replace

The picnic tables are in good condition with no broken pieces or appearance concerns noted at the time of inspection. Expect to replace every 10 years to maintain appearance. Remaining life based on observed conditions.

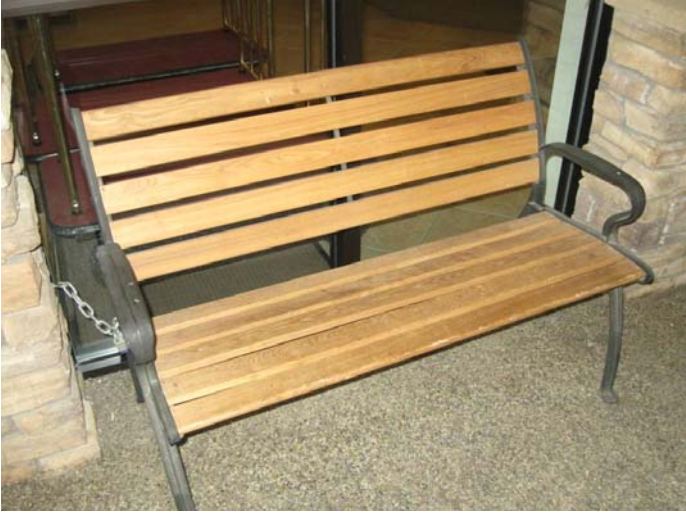
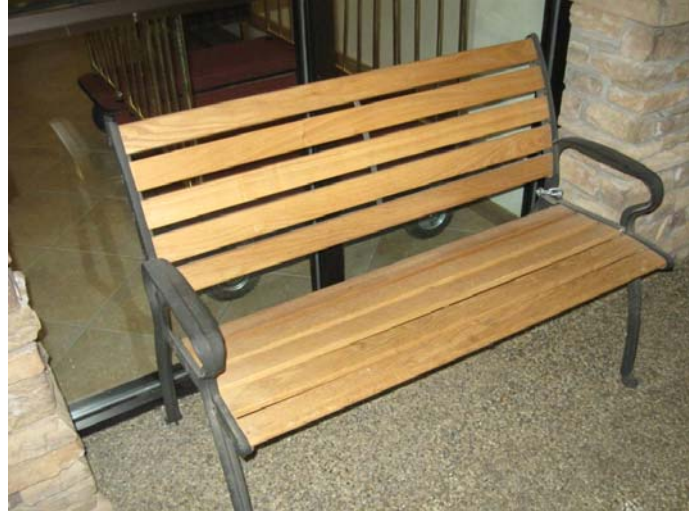
Comp #: 1307 Benches - Replace

Benches are in good to fair condition. Generally benches are aging normally. Replace as needed with operating funds.

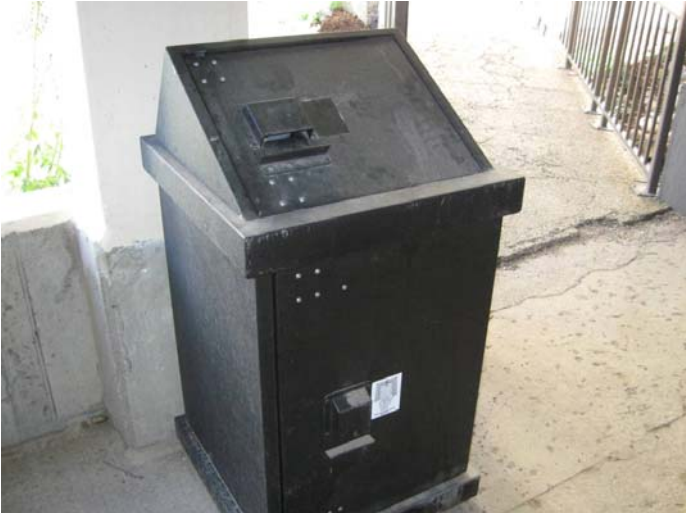
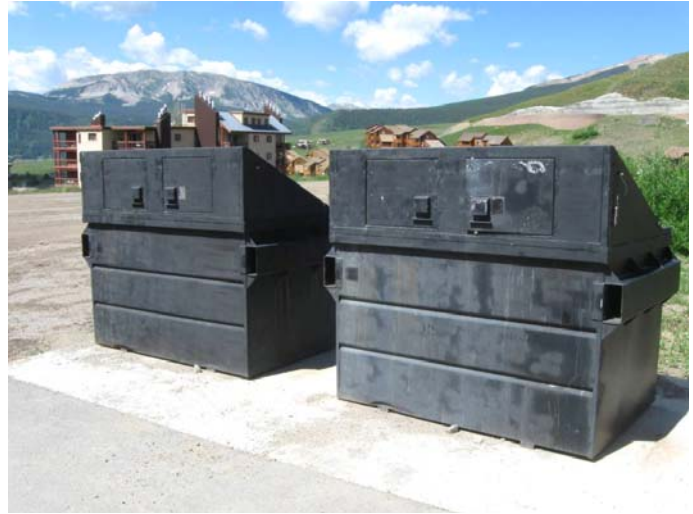
Comp #: 1308 Bear Proof Trash Receptacles - Replace

Painting and roofing is included with separate components. Expect frequent repairs and replacement to the gates and possibly the siding due to the exposure to elements and probability of abuse from rubbish companies. In our experience, we typically see the need for repairs every 5 - 10 years, depending on the level of abuse.

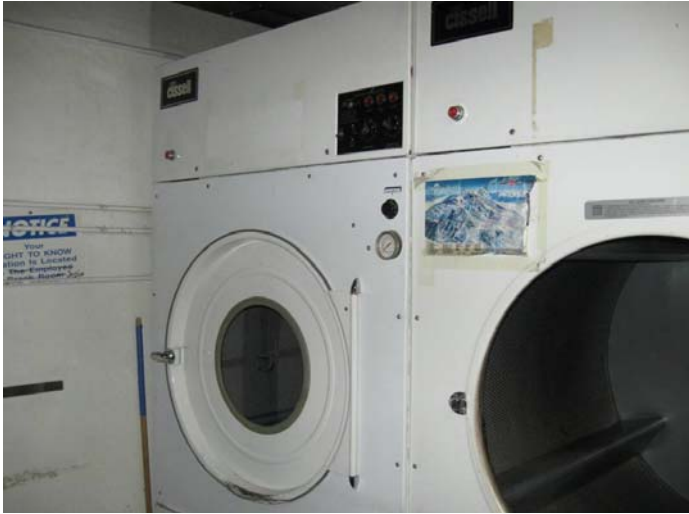
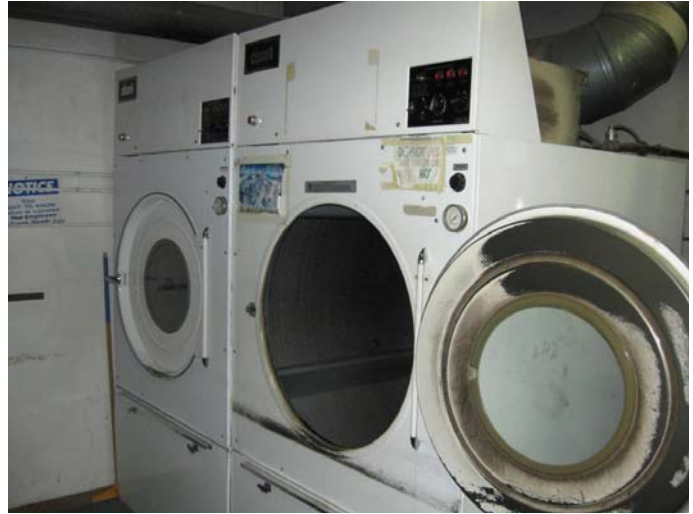
Comp #: 1401 Laundry Equipment (Dryers) - Replace

It was reported that these machines are owned by the Homeowners Association. These machines appear to be original based on the dates of installation. Reserve funding is for complete replacement of the machines every 12 - 15 years. Annual maintenance, repairs and servicing should be handled with operating funds. Since these machines are original and even though they are working well, we recommend replacing these machines soon rather than later just for gas use efficiency and long term cost saving reasons. This was the recommendation provided my both Milnor and Martin Ray.

#1 Model L44CD42G; s/n 6026-484
2010 recommended equivalent replacement
(1) Milnor Mod: M82 (70lb) - \$6000 est. cost

#2 Model L44CD42G; s/n unreadable
2010 recommended equivalent replacement
(1) Milnor Mod: M122 (120lb) - \$10,000 est.cost

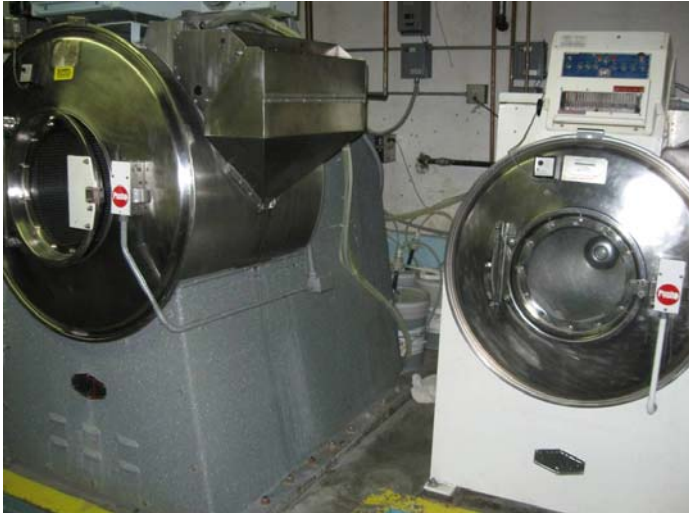
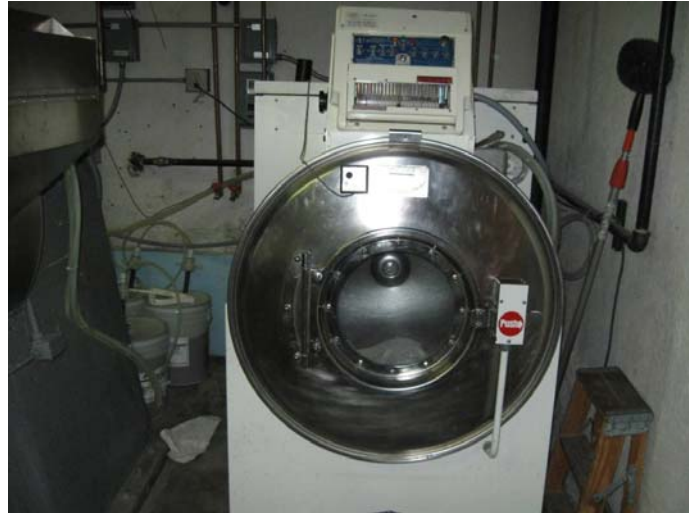
Comp #: 1402 Laundry Equipment (Washers) - Replace

It was reported that these machines are owned by the Homeowners Association. These machines appear to be original based on the dates of installation. Reserve funding is for complete replacement of the machines every 25 - 30 years. Annual maintenance, repairs and servicing should be handled with operating funds. Remaining life is based on age of the machines. Since these machines are original and even though they are working well, we recommend replacing these machines in the next 4 - 5 years for water efficiency and long term cost saving reasons. This was the recommendation provided my both Milnor and Martin Ray.

- (2) Commercial grade washers
- #1 Pellenn Milnor Corp., model 3002005M/ABB;
1983; s/n 4366801/84012;
50lb capacity (no longer manufactured)
2010 recommended equivalent replacement
Milnor Mod: 30022T5X (60lb) - \$12,000 est. cost
- #2 Pellenn Milnor Corp., model 36026QWE/AFE;
1984; s/n 4672101
100lb capacity (still manufactured)
2010 recommended equivalent replacement
Milnor Mod: 36026V5J (1200lb) - \$21,000 est. cost

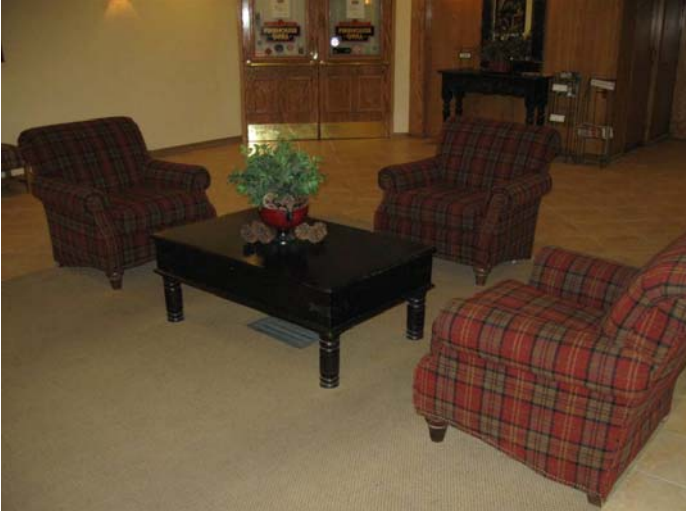
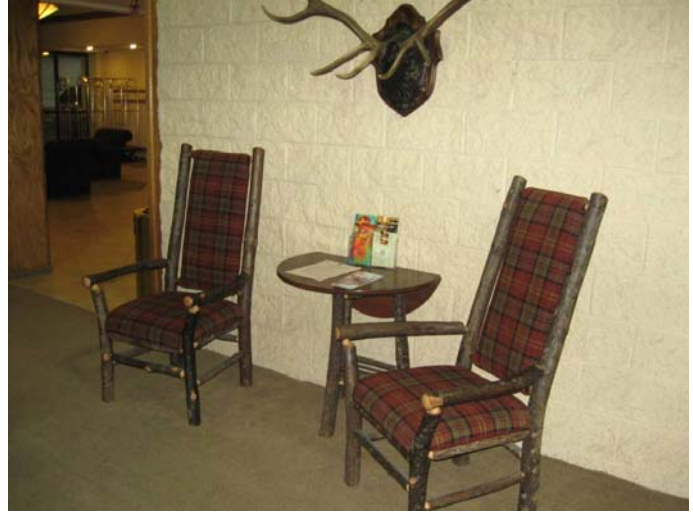
Comp #: 1405 Furnishings - Replace

Furniture is generally in good to fair condition. No significant marking or appearance concerns noted at the time of inspection. Reserve to make significant replacements to furniture approximately every 10 years to maintain appearance and keep up with decorative tastes. Remaining life based on observed conditions.
