Plaza Condominiums
11 Snowmass Road
Mt. Crested Butte, CO 81225

Level 1 Reserve Analysis

Report Period – 01/01/11 – 12/31/11

Date of Property Observation - July 15, 2010
Project Manager - Steve Kelsen
Main Contact Person - Mr. Eli Haine, Community Manager

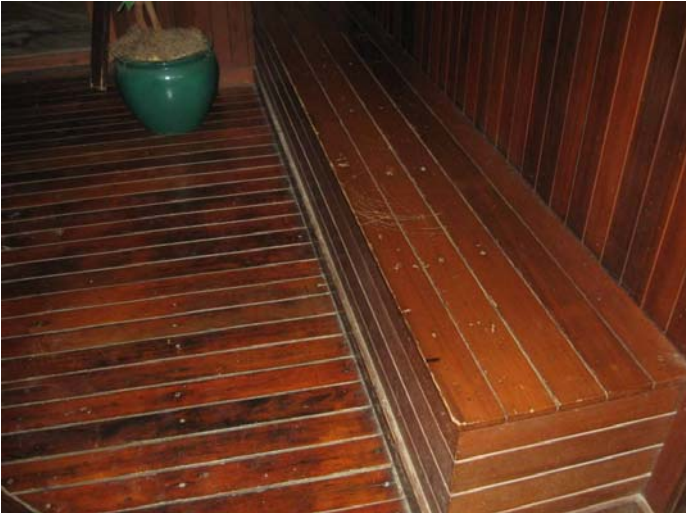
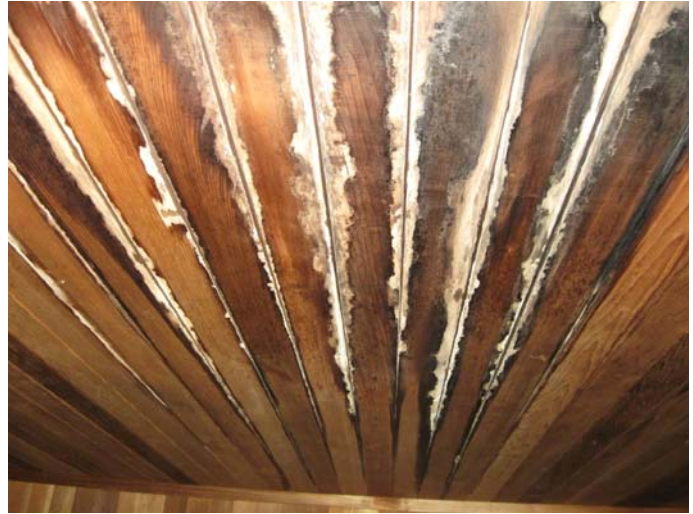
Comp #: 1409 Sauna/Spa Room - Refurbish

The sauna appears to be original and is in poor condition. The ceiling wood is moldy & beginning to sag and should be repaired immediately. The wood surrounding the spa area is dated and showing signs of wear. This should be refurbished shortly after the steam shower project is completed to maintain a proper appearance for the Association. Remaining life is based on observed conditions.

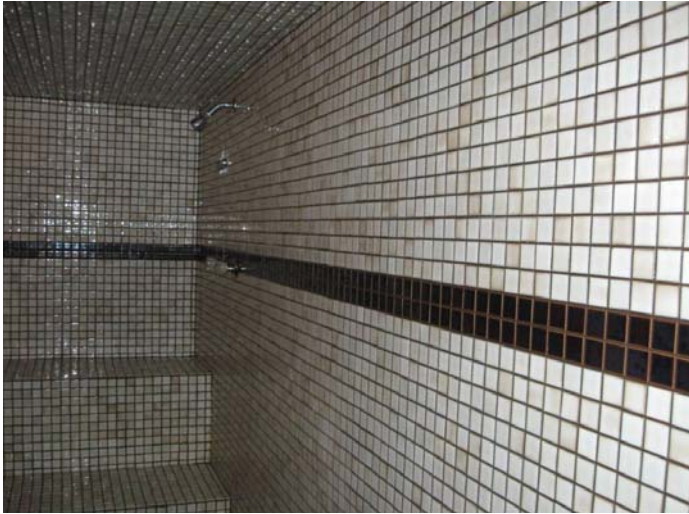
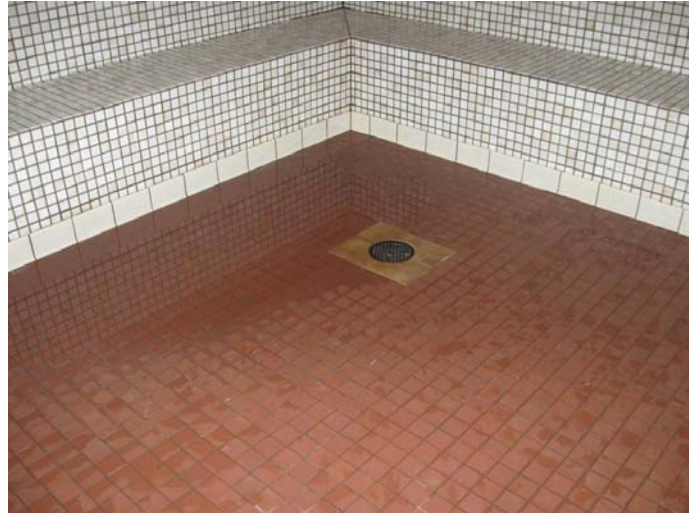
Comp #: 1411 Steam Room - Remodel

The tile is original is showing its age. It was reported that based on the "Six Year Capital Plan" established by the Association, the steam shower tile will be replaced this coming 2010/2011 fiscal year. The Association should reserve to replace this tile every 15 - 20 years depending on levels of use.

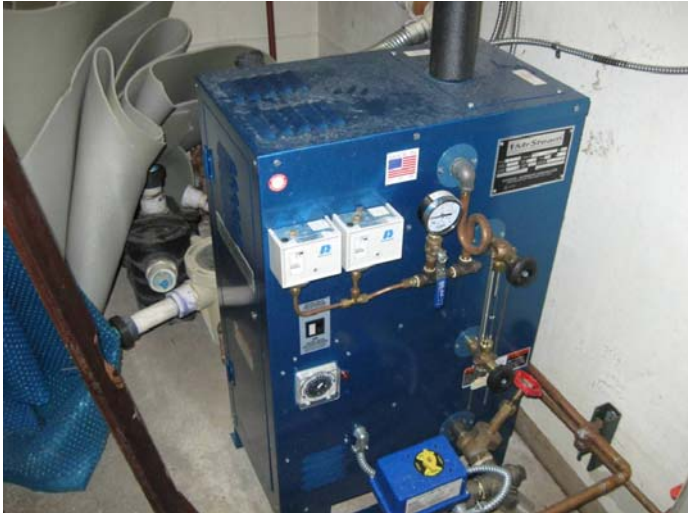
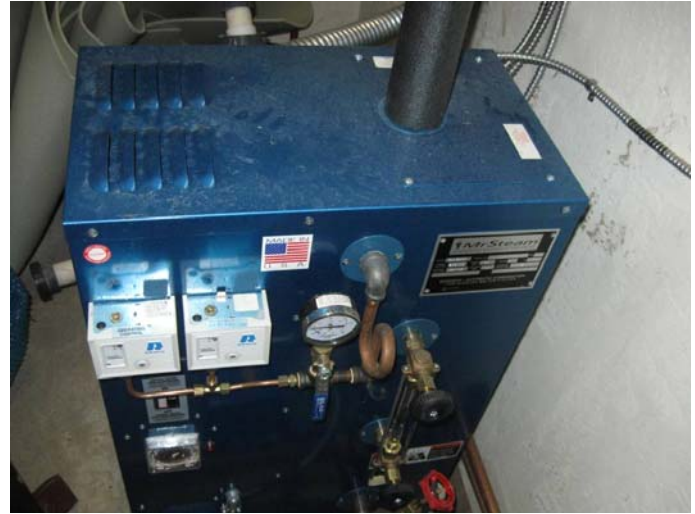
Comp #: 1412 Steamer - Replace

It was reported that this unit was replaced in 2010. The useful life of this unit should be between 18 - 20 years depending on levels of use.

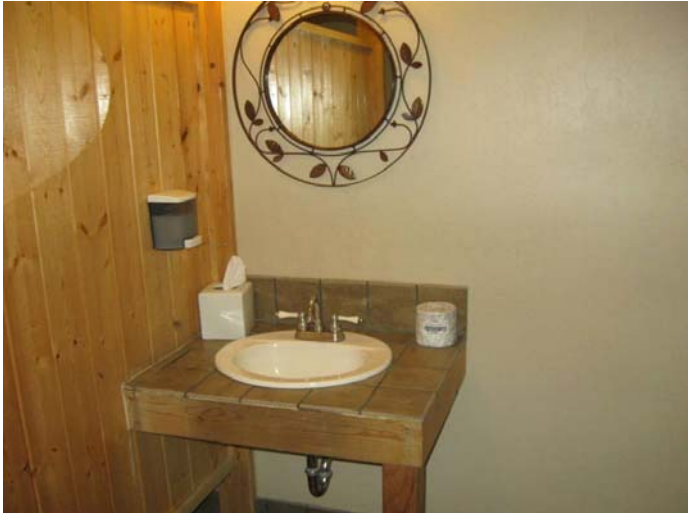
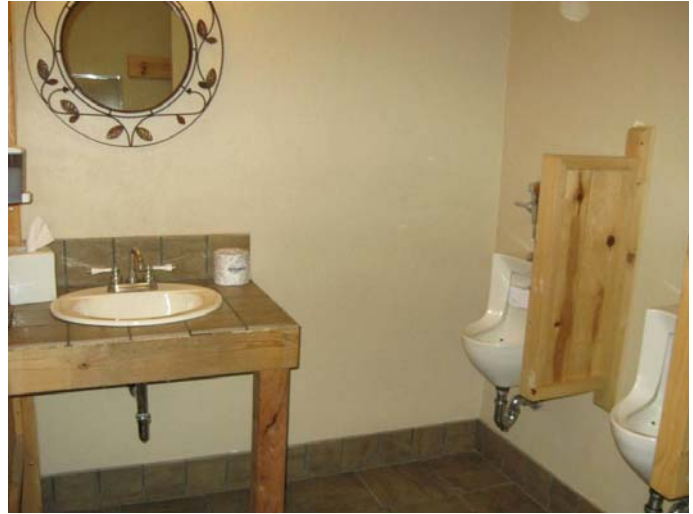
Comp #: 1413 Restroom - Remodel

It was reported that the restrooms were remodeled sometime in the last 5 - 6 years. Most Associations perform a general remodel of the restroom/locker room interiors every 15 - 20 years to maintain appearance and keep up with current decorative trends. The final decision is up to the Association members in deciding when to spend the money to perform this project since it is considered cosmetic. Remaining life based on age since last remodel.

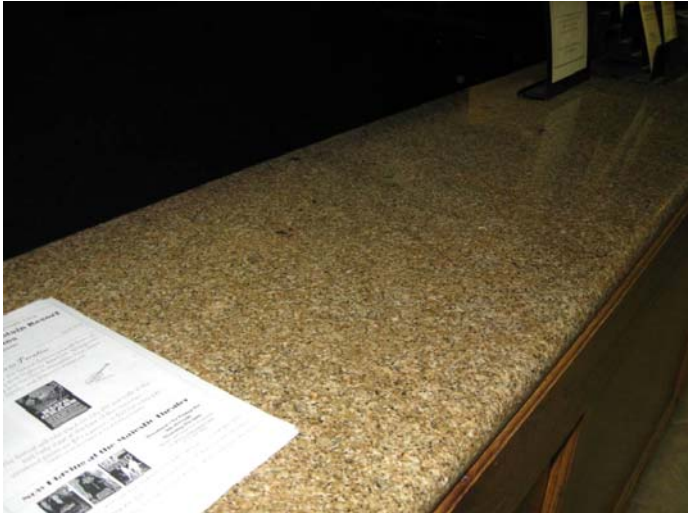
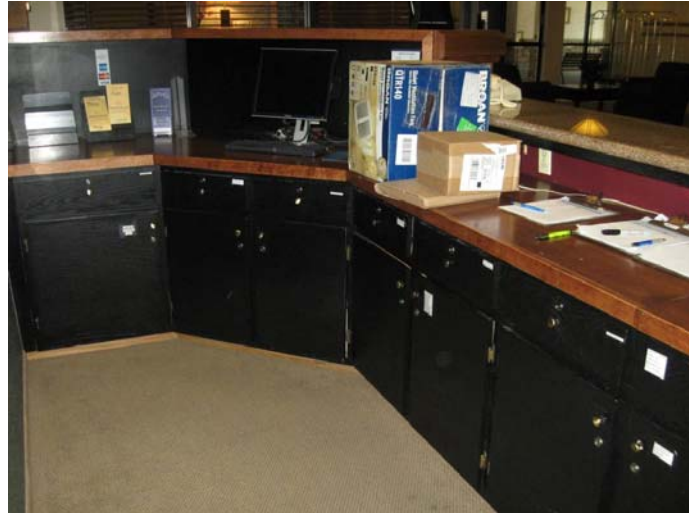
Comp #: 1415 Front Desk/Reception Area - Remodel

It appears that some remodeling work has occurred in the past but overall the reception desk area is beginning to show signs of wear. The Association should Reserve to remodel this area every 12 - 15 years to maintain a proper appearance for this level of property. Remaining life is based on observed conditions.

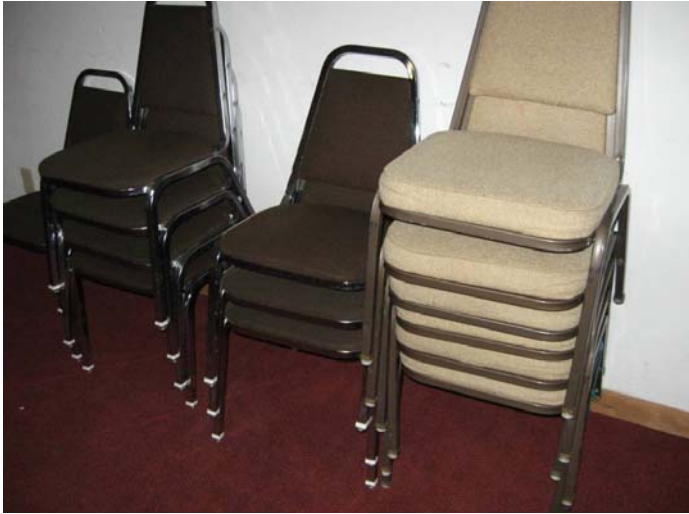
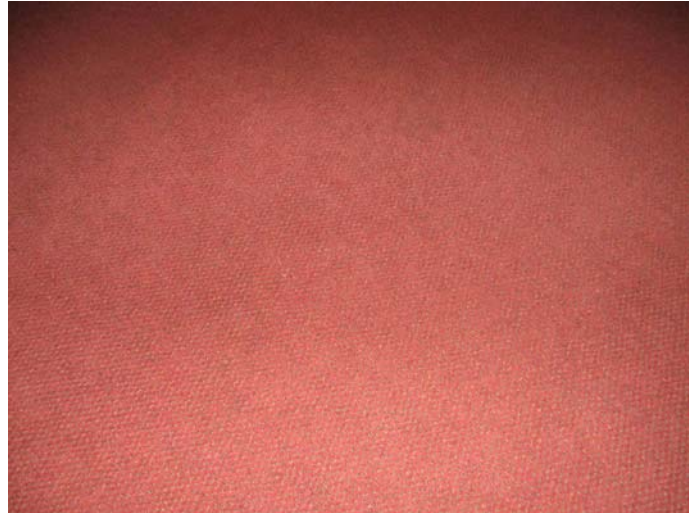
Comp #: 1416 Conference Room - Remodel

The conference room is dated and in need of a remodel in the next few years to stay up with current trends. In addition, it was reported that the conference room furniture is very old (probably original) and in need of replacement. Remaining life has been extended to ease budget concerns due to other projects higher on the priority list being completed over the next couple of years.

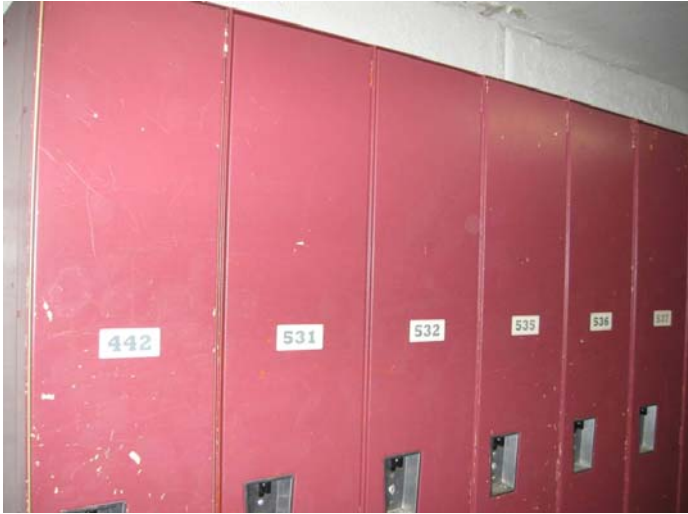
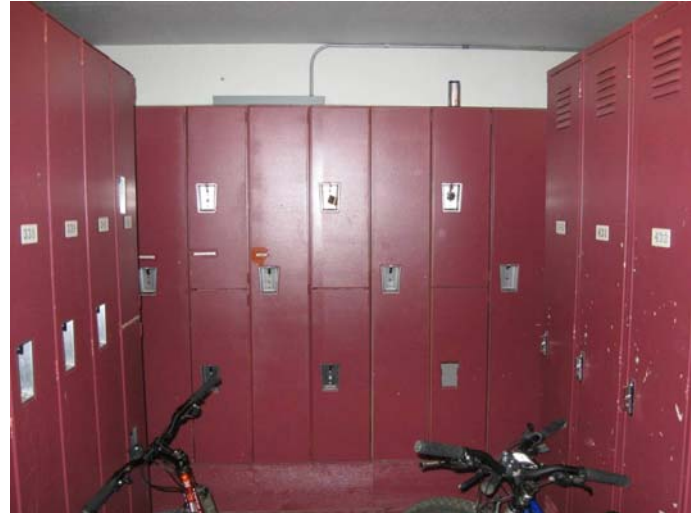
Comp #: 1419 Ski Locker Room Remodel

The ski locker rooms are very dated and are in need of a remodel. The Association should Reserve for basic upgrading and remodeling every 10 - 12 years based on the amount of use and abuse these areas receive. Remaining life is based on observed condition.

Room #1 - in poor condition, needs major work
carpet - 107 GSF; painted walls - 67 GSF; painted ceiling - 107 GSF; (1) painted door; (1) wooden bench; (1) ceiling light; 35 (1x6) metal lockers

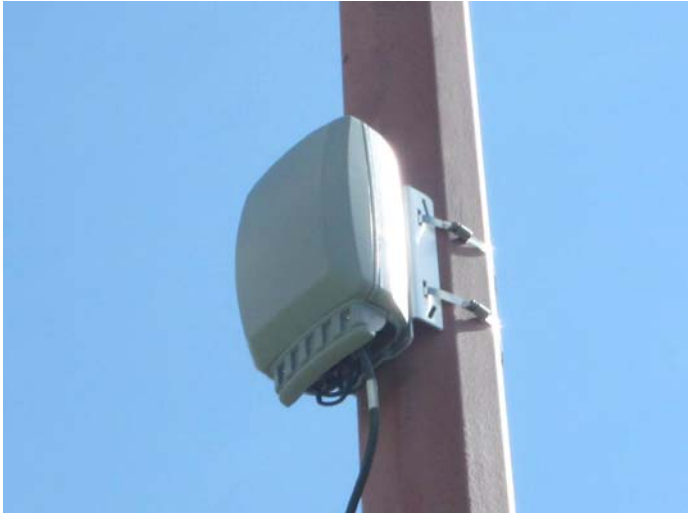
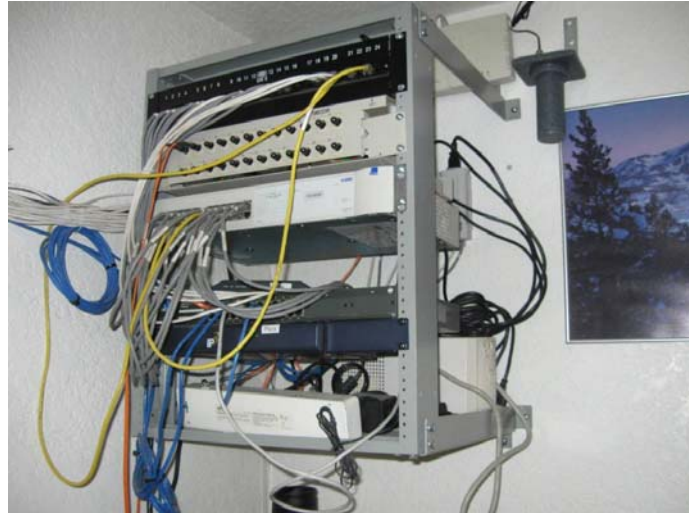
Comp #: 1420 Wireless Internet System

It was reported that the wireless internet system is approximately 6 years old and should be upgraded in the next couple of years. Reserve to replace system every 7 years to stay current with improvements in technology.

NOTE: Cost provided by Internet Colorado. A leasing program was also recommended in place of purchasing the equipment. This can be decided at a later time. If leasing the equipment is the direction the Board decides to go with, funding for this component will be removed since this will be an annual expense.

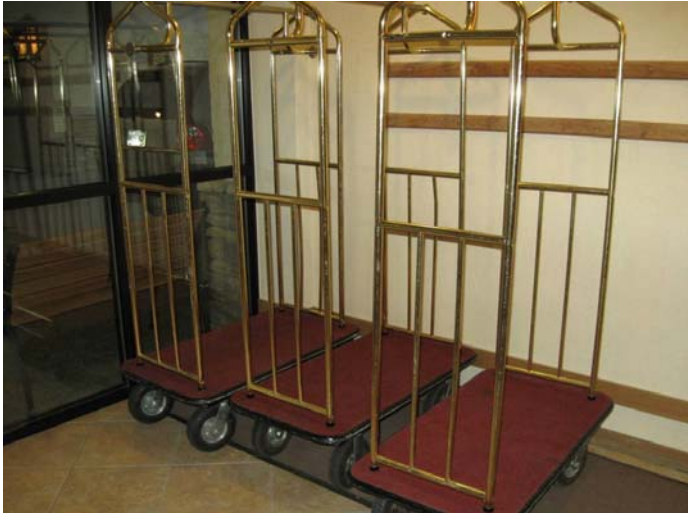
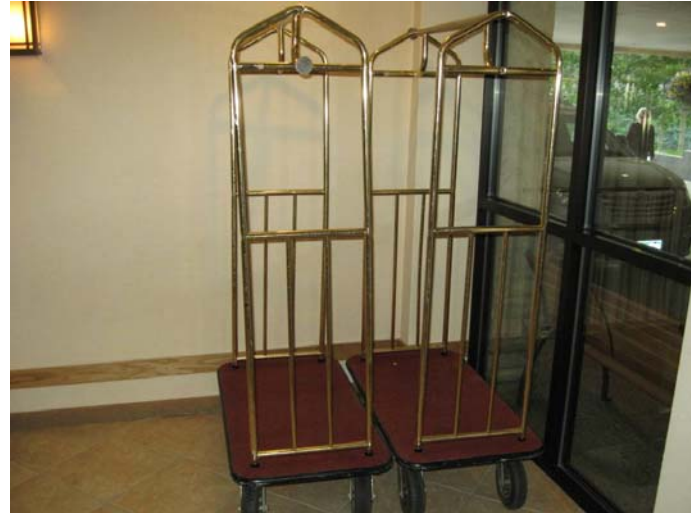
Comp #: 1428 Luggage Carts

Conditions vary depending on level of use and abuse. Most were still functional, but appear to be about half way through the life expectancy. The Association should plan on replacing the luggage carts every 6 - 8 years depending on levels of use and abuse. Remaining life is based on observed conditions.

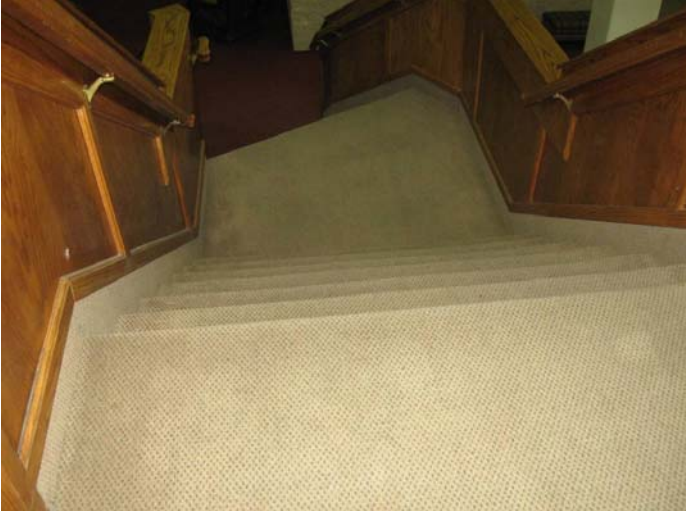
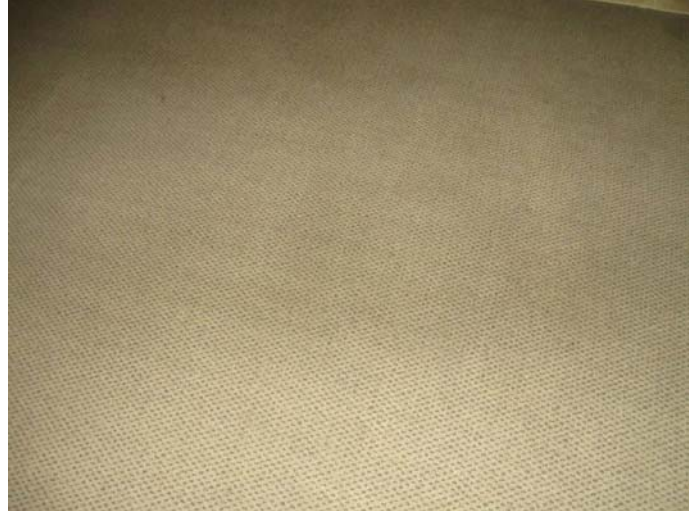
Comp #: 1501 Carpeting - Replace

Carpet is in fair to poor condition. There is evidence of wear noted but no rips or curling seams observed at the time of inspection. Expect to replace this component every 10 years assuming normal use and wear. Remaining life based on current age and observed condition.

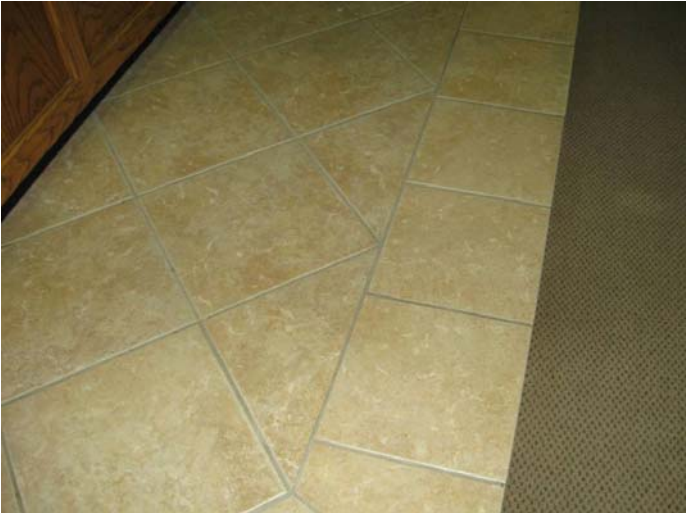
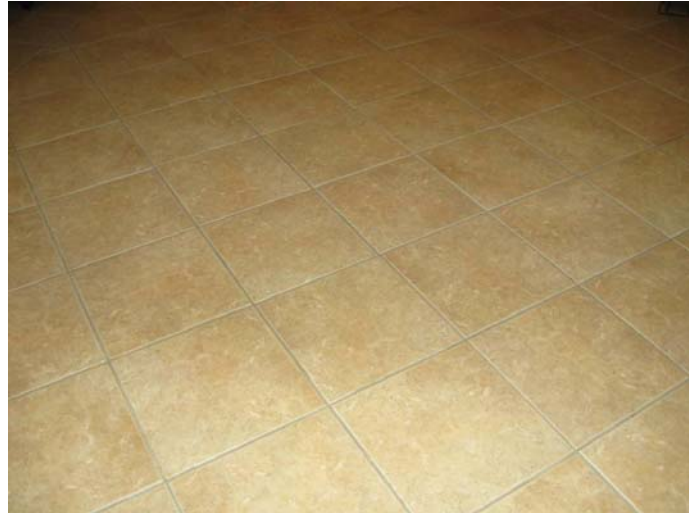
Comp #: 1503 Ceramic Tile - Replace

The lobby tile appears to be in good condition. Reserve to update tile every 18 - 20 years to maintain appearance and keep up with decorative trends. Remaining life is based on observed condition.

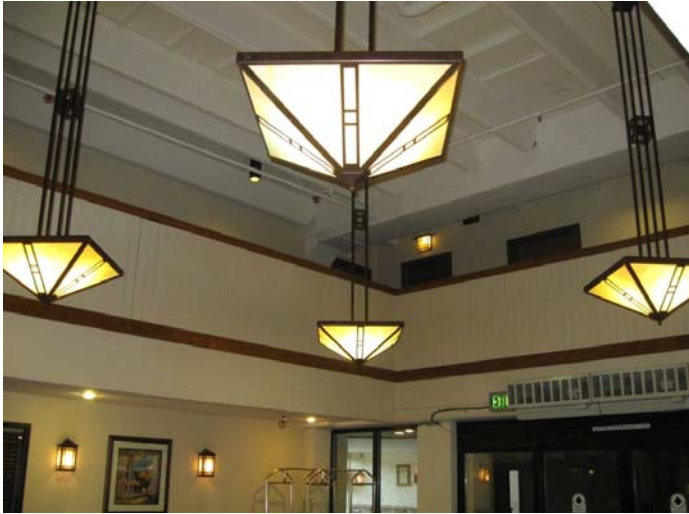
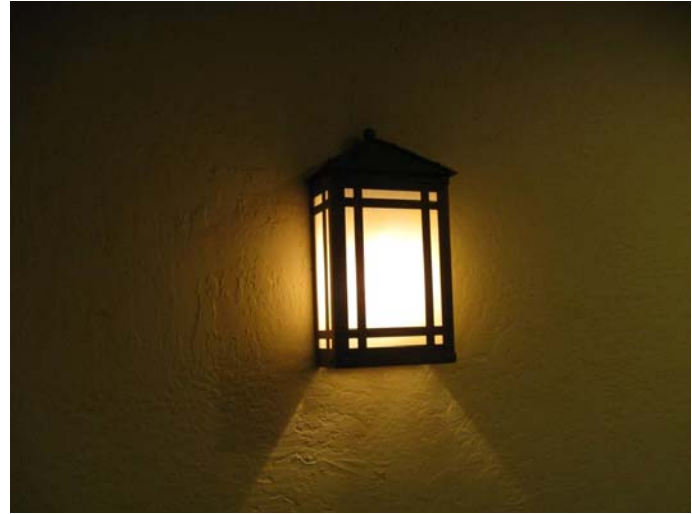
Comp #: 1601 Interior Lobby Lighting - Replace

Existing lights are in good condition but it was reported that there is a Lobby lighting project planned for the fiscal year 2011/2012. Expect to replace these lights approximately every 20 years to maintain appearance and keep up with current decorative tastes. Remaining life based on current upgrade plan.

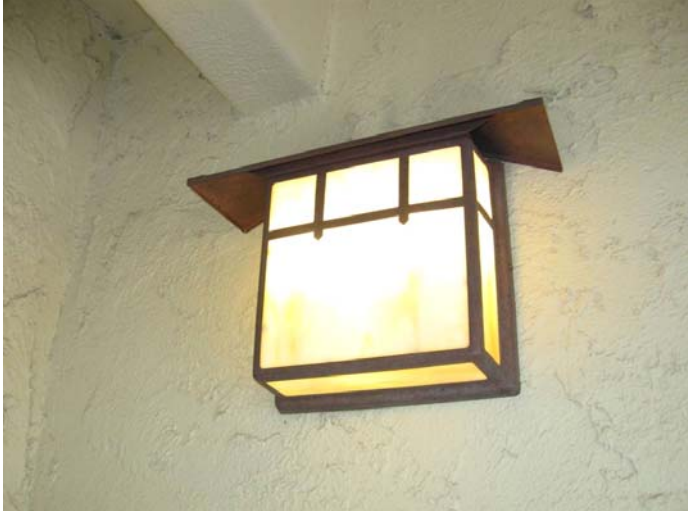
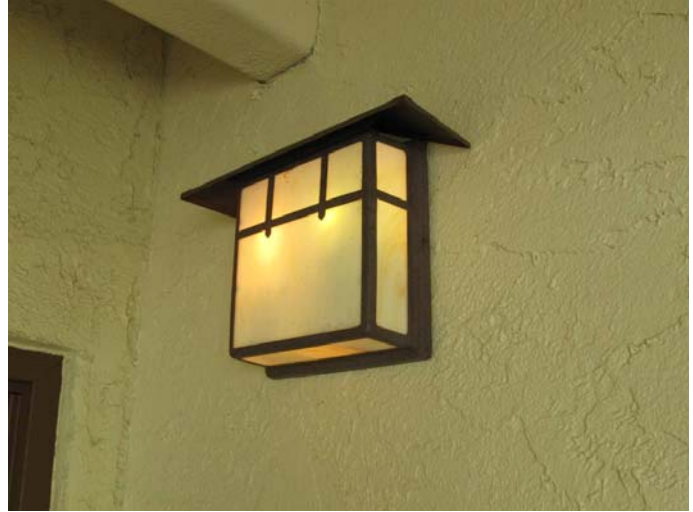
Comp #: 1602 Exterior Lighting - Replace

The lights appear to be newer but it is unclear as to when the light replacement last occurred. No unusual conditions were observed or reported at time of inspection. While replacement can occur on an as needed basis, it is our opinion and recommendation to replace all lights at the same time every 15 - 20 years to maintain a consistent appearance throughout the property. In addition, by replacing multiple fixtures, the Association will be able to obtain a quantity discount for the fixtures. Estimated replacement cost includes labor for installation. Remaining life is based on current condition.

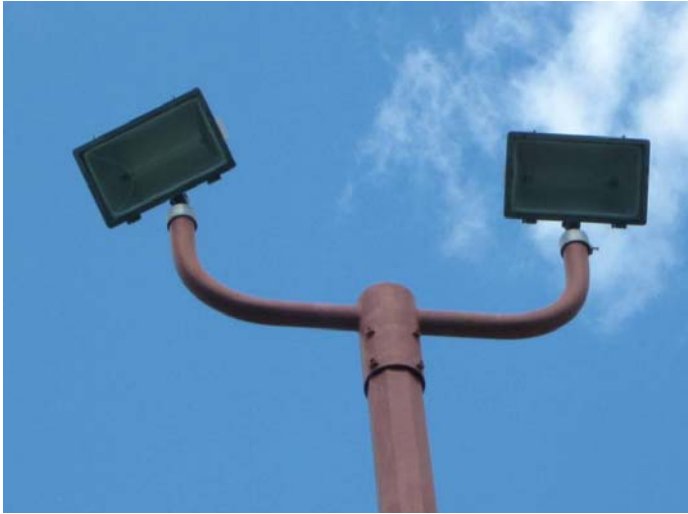
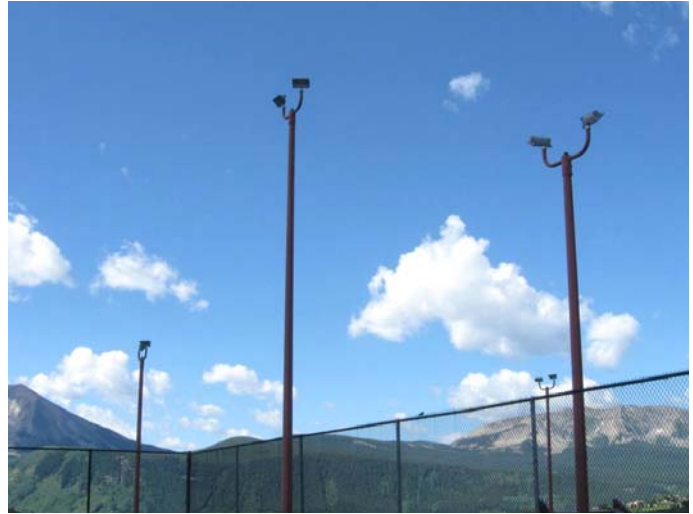
Comp #: 1604 Pole Lights - Replace

No structural or operational problems reported with lights at the time of inspection. Due to the extended life associated with light poles reserve funding is not appropriate. Reserve only to replace fixture heads on a 16 year schedule to maintain appearance and function. Remaining life based on observed conditions.

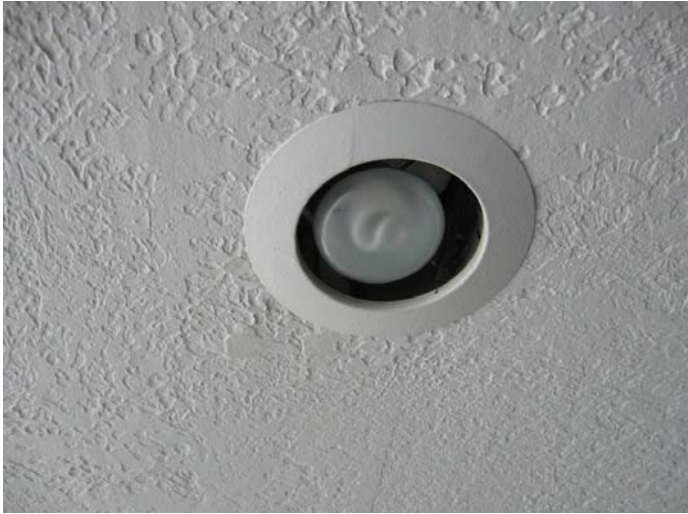
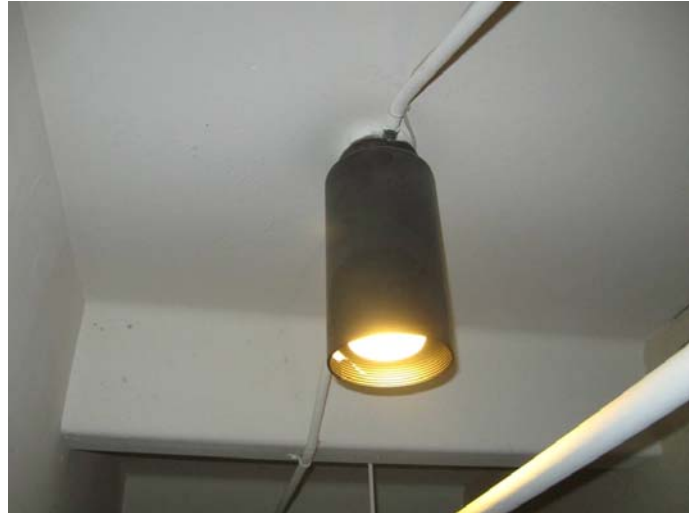
Comp #: 1608 Can Lights - Replace

No expectation to replace all lights at one time. Replace individual lights as necessary as an operating expense. No reserve funding necessary. If the Association would like to Reserve for future upgraded lighting for the surface mount cans, this can be added in future Reserve study updates.

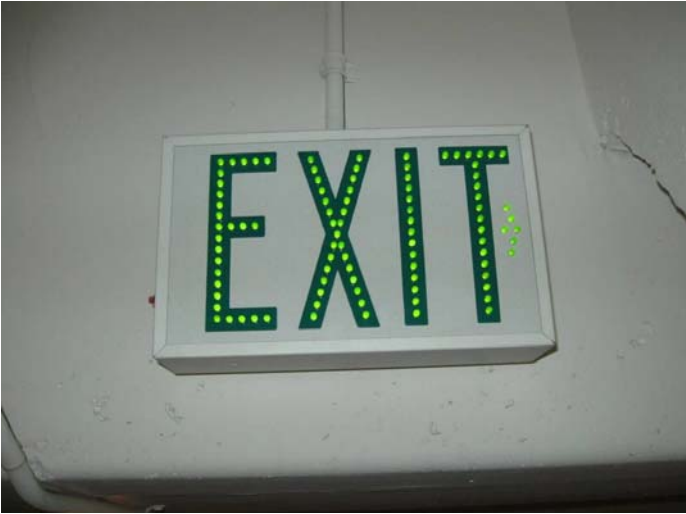
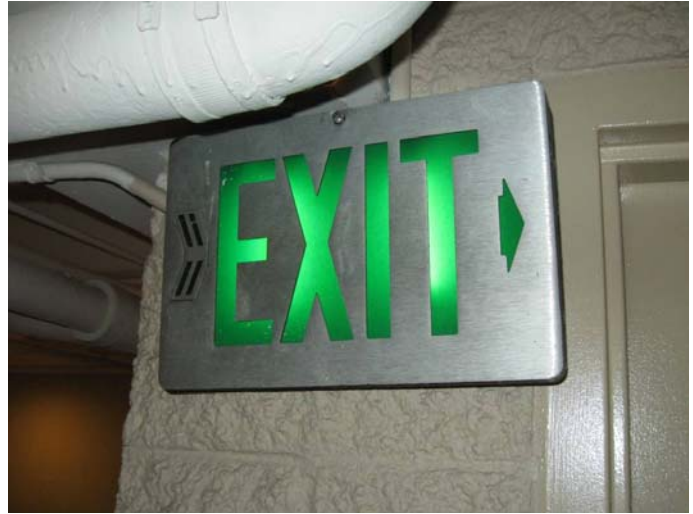
Comp #: 1611 Lighted Exit Signs - Replace

It is unlikely that all these will fail or need replacing at the same time. Replace as needed with operating funds. No Reserve funding needed at this time.

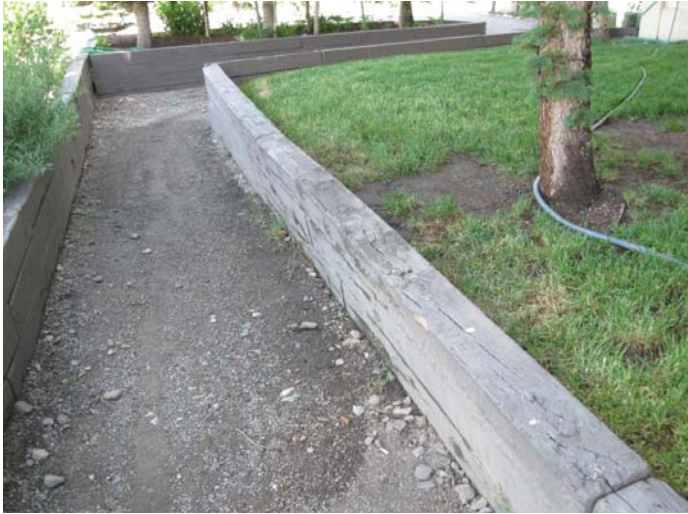
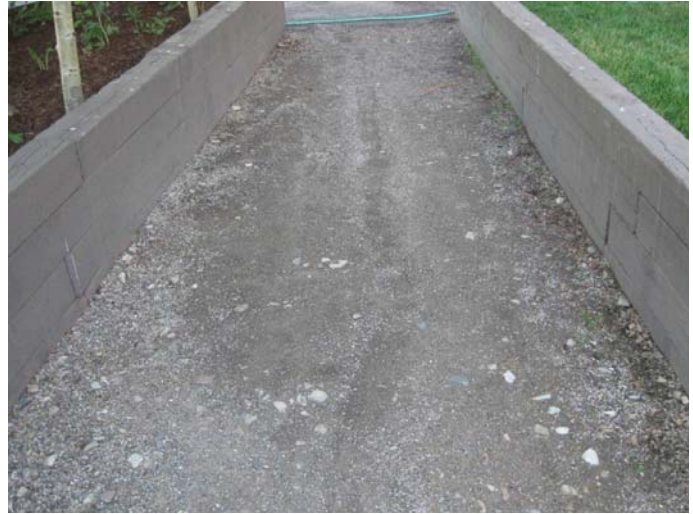
Comp #: 1813 Crushed Granite Paths - Replenish

Due to minimal square footage, Reserve funding is not required. Replenish as needed with operating funds.

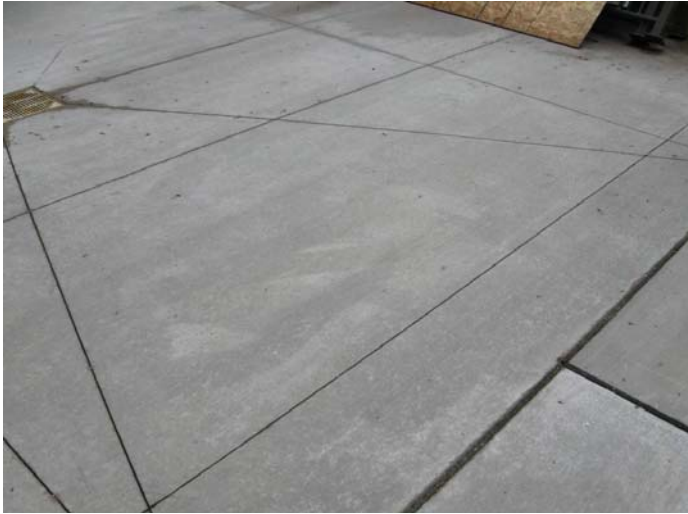
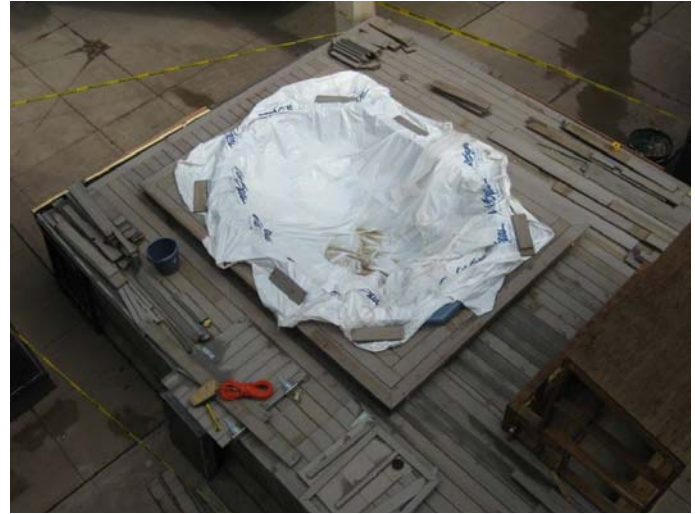
Comp #: 2020 3rd Floor Remodel

The 3rd level deck was in the process of being remodeled during the property observation. It was requested by the client to include a remodel of this area every 30 years because it also acts as the roof/ceiling to the entire lobby area. The cost scenarios have been reduced to account for the reaccuring components that need replacing sooner than a 30 year cycle. Remaining life is based on age since the most recent remodel in 2010.
